# ATLAS Muon MDT

# MROD-X Pre-Production Series Test Report

Document Version: 1  
Document Issue: 1  
Document ID: ATLAS-TDAQ-2006-XXX or EDMS Id XXXXXX  
Document Date: 07-Dec-2006  
Document Status: Draft

Fifteen pre-production modules were produced. This document describes the issues found during testing.

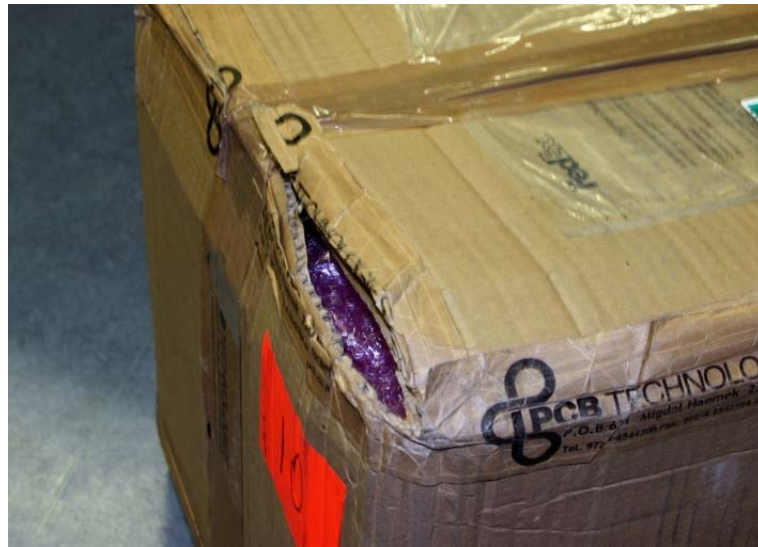
The way the modules were packed was not adequate. Both boxes were subjected to quite some external force which caused them to rip open (figure 1 and 2).

Figure 1: Box ripped open

Improve packaging; Boxes broken (Front panel suffered)

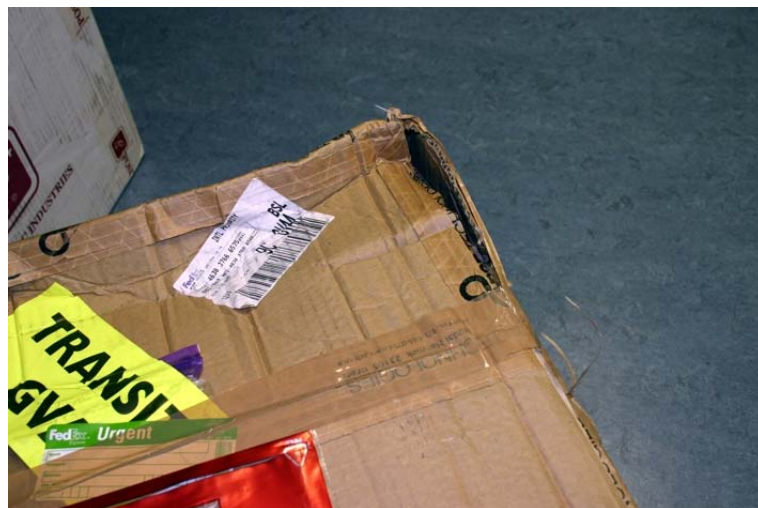
Figure 2: Other box also ripped open

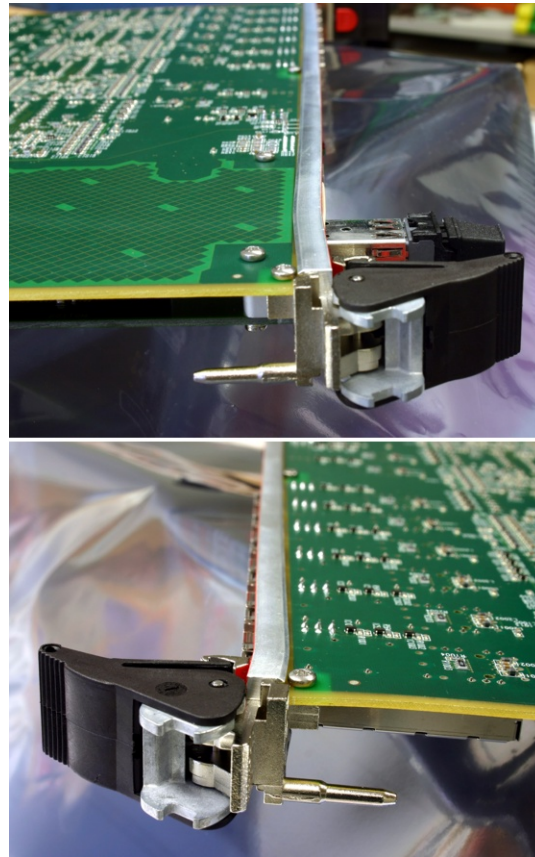
As a result of the poor packaging the front panel of one module was severely damaged (figure 3).

Figure 3: Damaged front panel

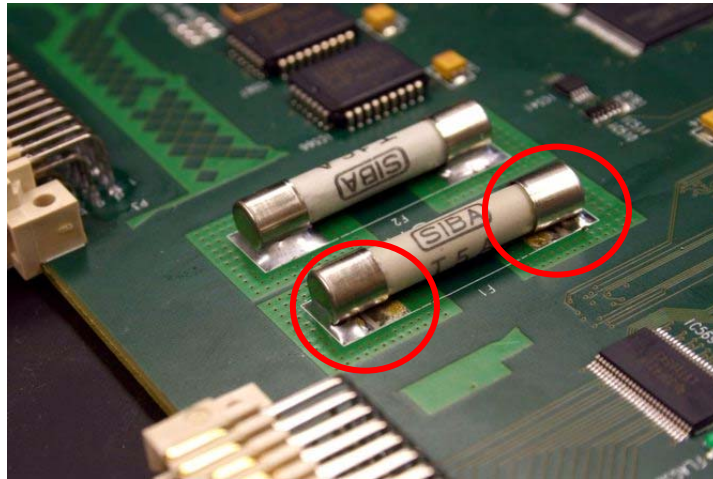
Before a closer inspection of the soldering joints, the eye was caught by the soldering joints of the fuses (see figure 4). It should be noted that these fuses are not made to be used as surface mount devices. However, the excessive currents drawn force us to solder the devices directly onto the board, rather than to use a fuse-holder that would cause too much contact resistance.

When heating the fuses, the end-caps tend to be blown off by the expanding hot air inside the fuse. So one need to find an optimum in reflowing the solder and trying to keep the end-caps in place.

Figure 4: poorly soldered fuses

Improve soldering of the Fuses. Try to keep the end-caps in place while reflowing the solder.

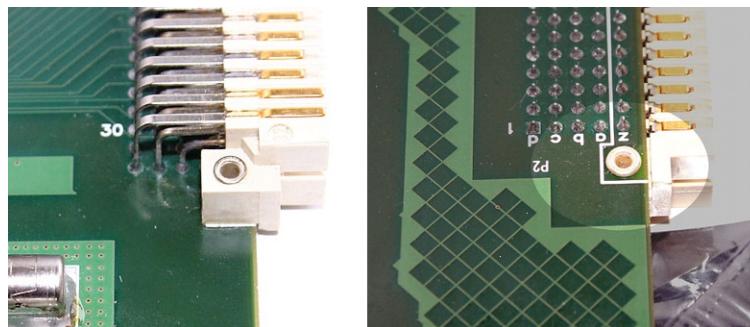
Figure 5: this example shows how the connectors on the prototype (not assembled by PCB Technologies) was mounted with rivets

When the boards were already assembled it became clear that PCB Technologies could not supply these rivets. It has been agreed to ship the pre-production series without a mechanical fixation on P1, P2 and P3 and to fix the connectors in Amsterdam.

For the main series one should first mechanically fix the connectors and than solder the connectors. The other way around may cause stresses in the soldering joint that could cause it to malfunction over time.

Mechanically fix P1, P2 and P3 before soldering

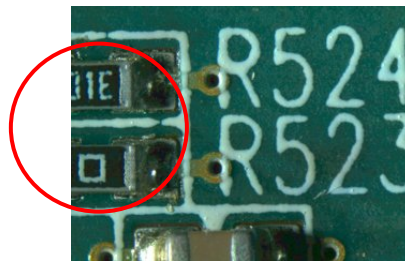
There are 6 resistors that configure the MROD to be a 6 or 8 channel module with or without a SHARC-B processor. As pointed out in the “assembly notes” and the “assembly list”, the Mentor Graphics database contains the values for a full featured module (8 channel with SHARC-B). However, the production MROD-X will be of type 6 channel, without SHARC-B.

Figure 6: R523 should be 1M (not 0Ω) and R524 should be 0Ω (not 1M)

R523 should be 1M (not 0Ω)

R524 should be 0Ω (not 1M)

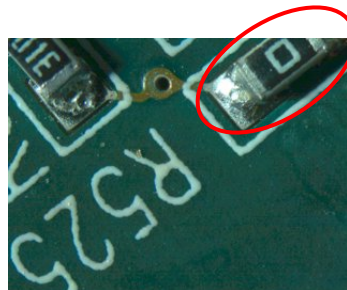
Figure 7: R525 should be 1M (not 0Ω)

R525 should be 1M (not 0Ω)

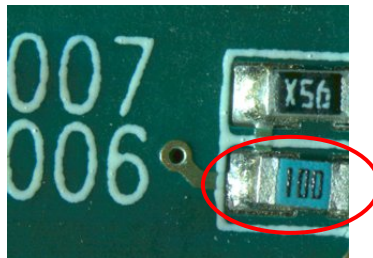
There are many (switched mode) power supplies on the board. The feedback resistors need to have the proper values to avoid over-voltage on the FPGAs or SHARC processors. All resistors had the proper value, except for one. It seems that there was a wrong tape placed on the machine since for all 100 ohm resistors, 10 ohm resistors were placed instead. This involves 15 resistors per module (R605, R608, R609, R610, R719, R720, R721, R1006, R2006, R3006, R4006, R5006, R6006, R7006, R8006)

The proper EIA-96 marking for a 100 ohm smd resistor should read "01A". However resistors with marking "100" were placed. This is not an EIA-96 marking and should be read as 10 times 10 to the power of 0, thus 10 ohm (see figure 10).

Figure 10: A 10 ohm resistor!

R605, R608, R609, R610, R719, R720, R721, R1006, R2006, R3006, R4006, R5006, R6006, R7006, R8006 should be 100 ohm (not 10Ω)

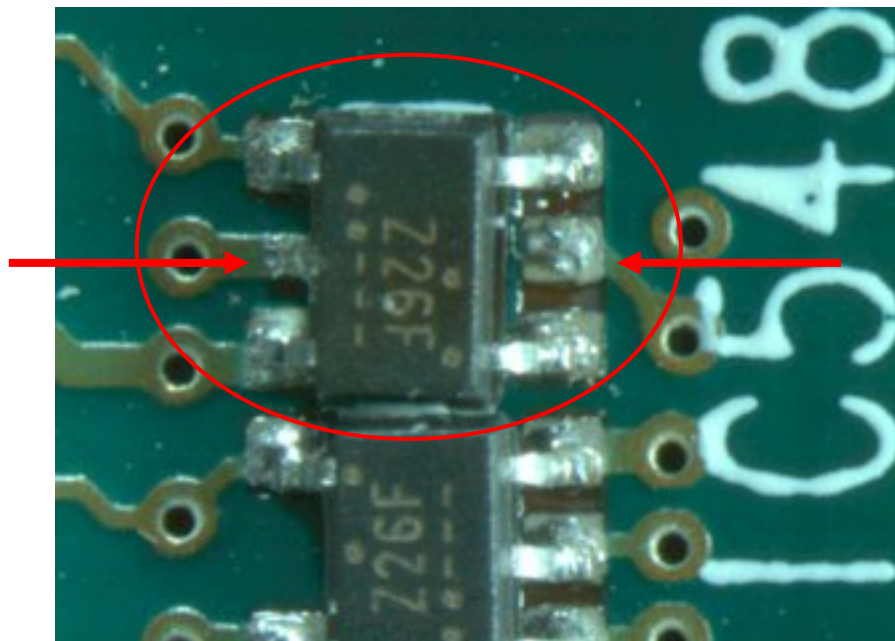
Figure 11: IC548 orientation 180 degrees

This error is most peculiar since the NC7SZ126P5X is delivered in a tape. In the factory these devices are automatically packed into this tape so it is not likely that a device is taped with the wrong orientation... What happened here?

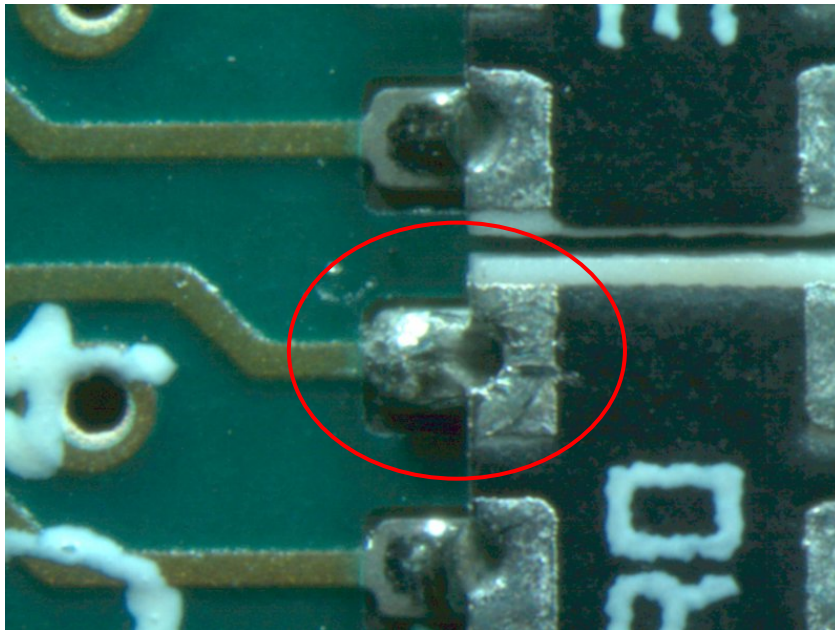
Figure 12: R204 pad not soldered propely

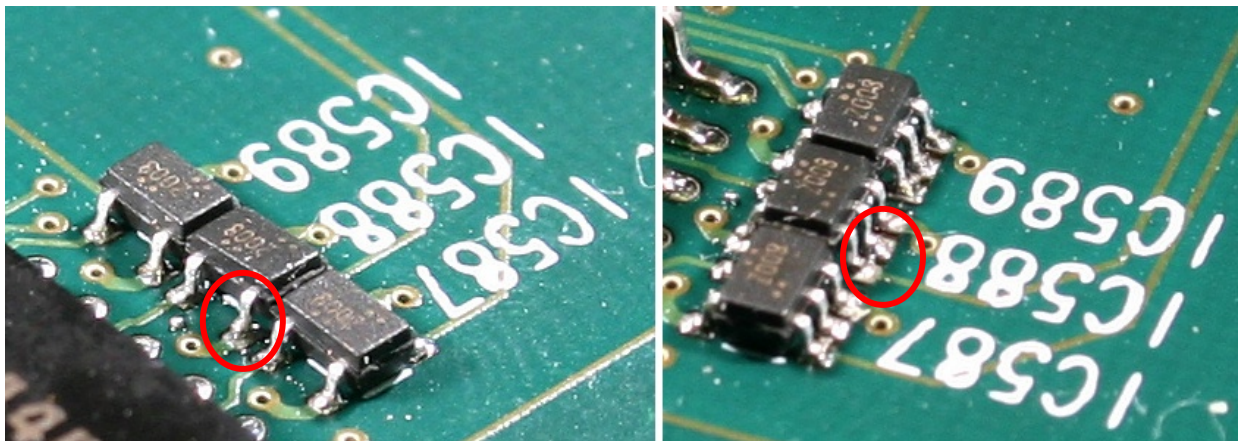
Figure 13: IC588 pin 1 and 5 above the PCB and not soldered

This fault is caused by the package of the NC7SZ00P5X which is not really flat on the PCB thus causing the pins to stand off from the PCB surface.

This seems to be a problem area on the board because the packages are too close together. See also paragraph 4.7. Extra attention is needed to make sure that these ICs are properly soldered.

Pay special attention to IC588 area

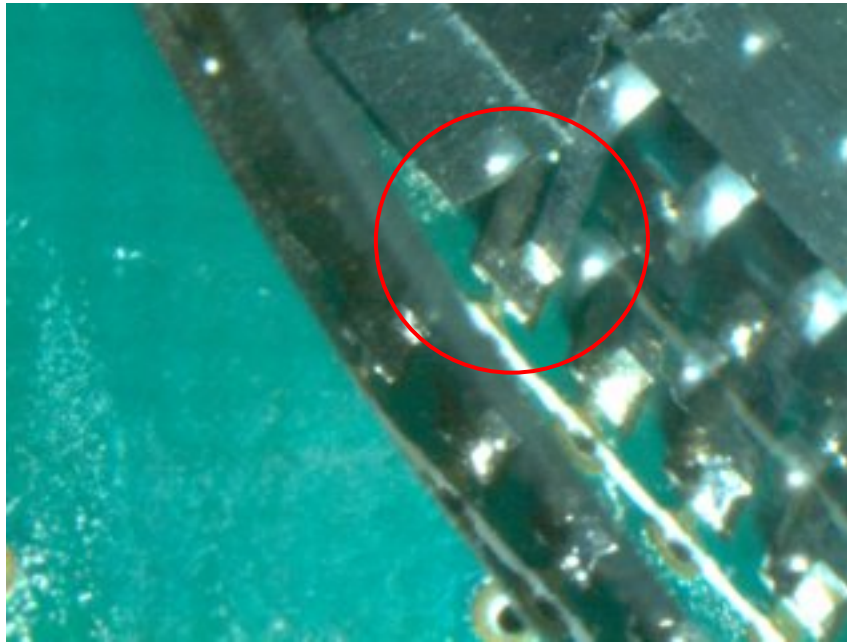
Figure 14: J24 pin 2 is not soldered

This fault is caused by the connector which is not really flat on the PCB thus causing the pin to stand off from the PCB surface. Note the picture was made using a mirror.

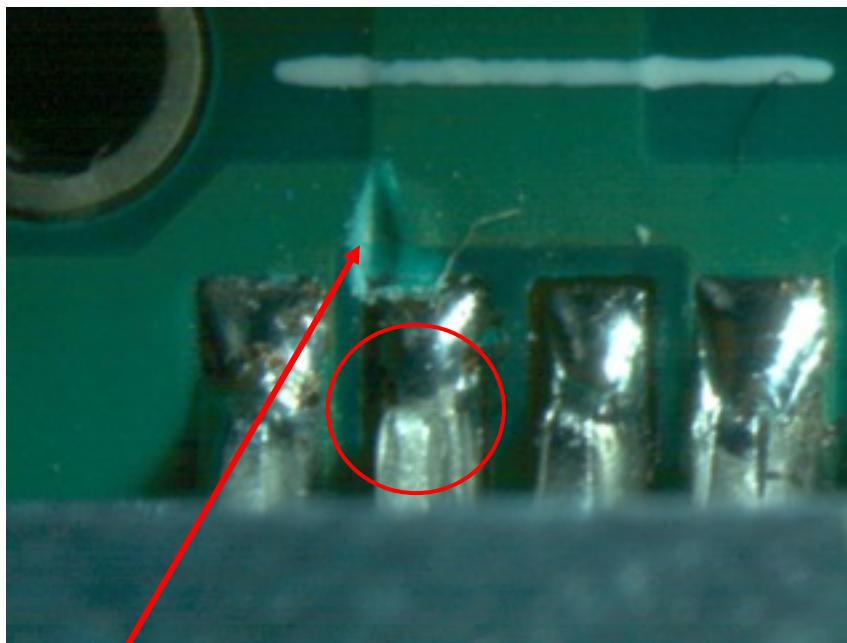
Figure 15: Loose pin 19 on connector IC2001

This is caused by the screw driver, used unlock the cage...

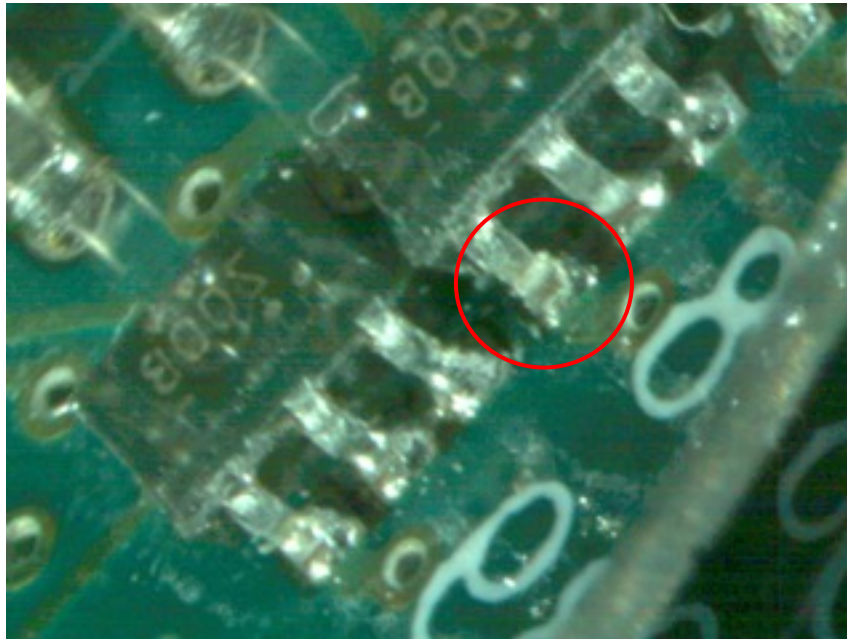
Figure 16: IC588 pin 3 not soldered

Mind the blurred picture; it was made using a mirror. This fault is caused by the package of the NC7SZ00P5X which is not really flat on the PCB thus causing the pins to stand off from the PCB surface.

This seems to be a problem area on the board because the packages are too close together. See also paragraph 4.4. Extra attention is needed to make sure that these ICs are properly soldered.

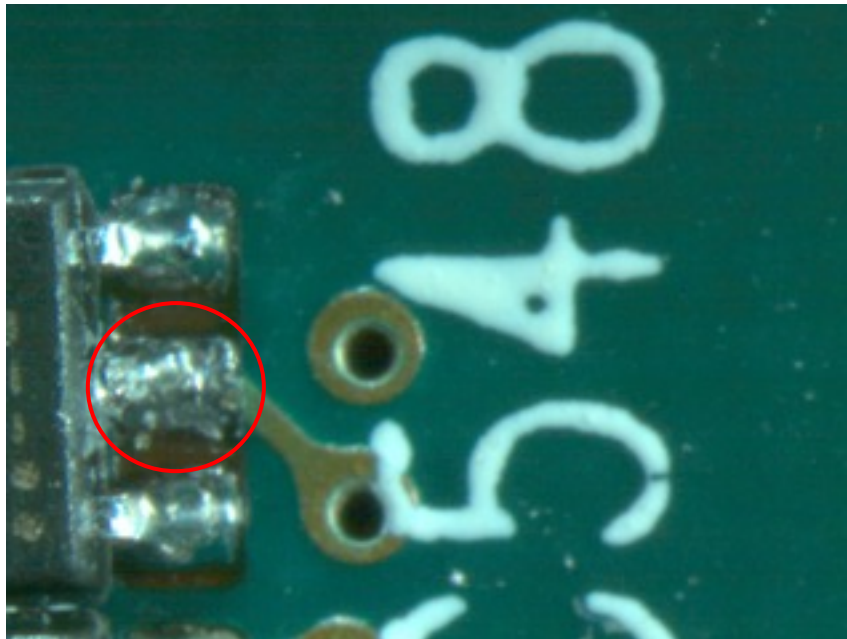
Figure 17: IC548 pin 2 not soldered

This is one of the errors that would have been difficult to find for an Automatic Optical Inspection.

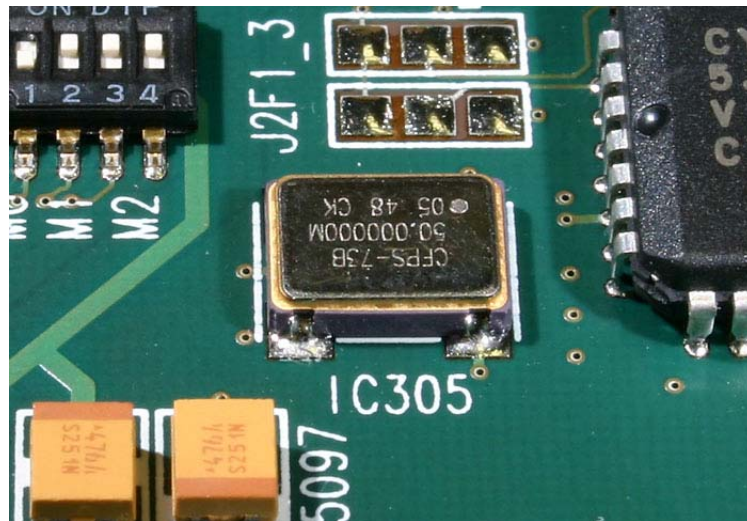
Figure 18: IC305 has wrong orientation

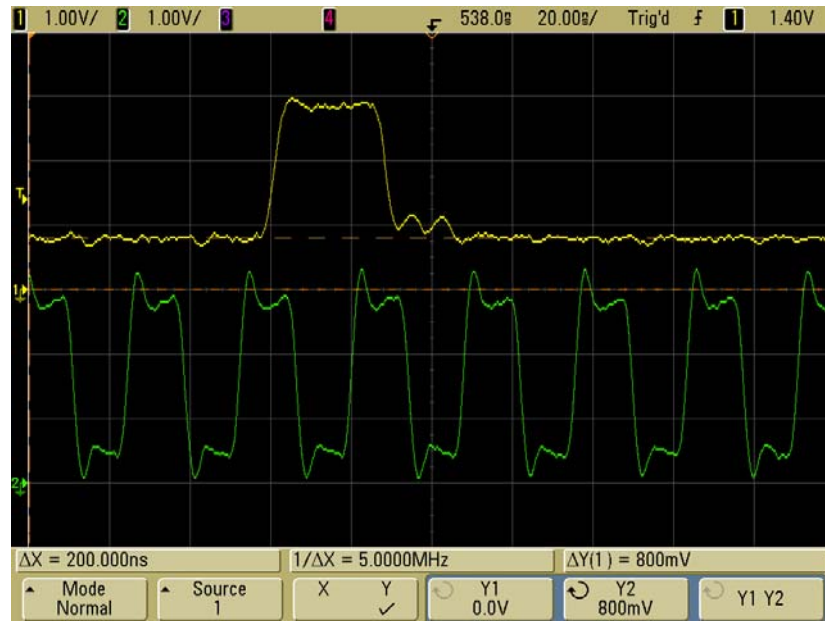
However, certain modules (V2) sometimes did not configure properly. Investigation of the configuration bus data bits shows that the signals marginally come below 0.8 Volt (see figure 19).

Figure 19: Trace 1: MRI\_D4; Trace 2: MRI\_CCLK (@ 40 MHz), Cursors at 0.8 Volt.  
Termination 3V3 -> 82 ohm -> MRI\_D4 -> 130 ohm -> Ground

It was chosen to remove the termination resistors (R676a-h, R677a-h) for the data bits and to lower the configuration frequency from 40 to 20 MHz to avoid the reflections on the lines. In fact this same scheme was used successfully on the six prototype modules (V1a).

Don't place R676a, R676b, R676c, R676d, R676e, R676f, R676g, R676h

Don't place R677a, R677b, R677c, R677d, R677e, R677f, R677g, R677h

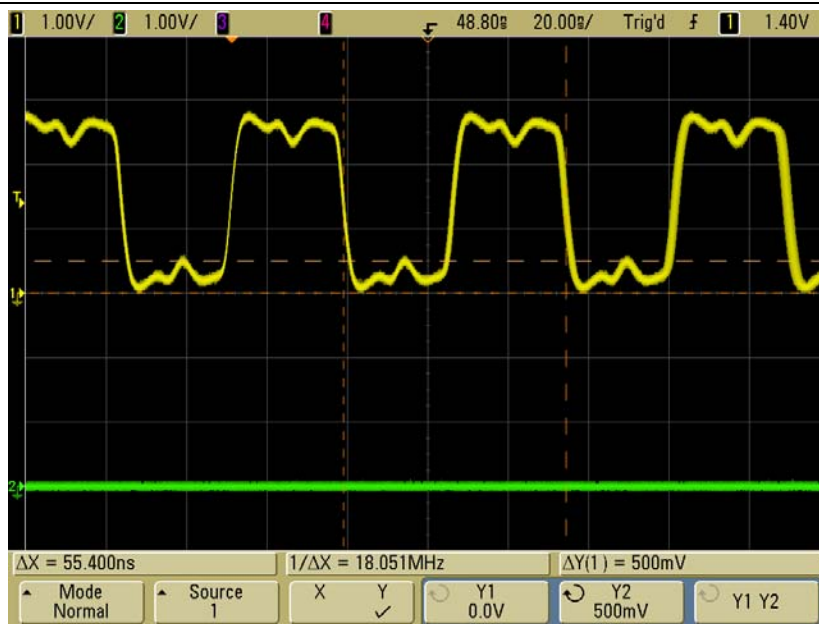
On the proto type modules (V1a), the clock line was terminated in a 100/100 ohm fashion. For the pre-production (V2) series it was chosen to use a more conventional TTL scheme of 82/130 ohm (resistors R672 and R675). The Thevenin equivalent voltage for this termination is 2 Volt which turns out to be too high since the sink capability of the drivers in the configuration PROM (XCF08P) is not very strong. Therefore the termination scheme was changed to 130/82 ohm which has a Thevenin equivalent voltage of 1.2 Volt. The resulting clock signal can be seen in figure 20.

Figure 20: Trace 1: MRI\_CCLK (@ 20 MHz), Cursors at 0.5 Volt. Termination 3V3 -> 130 hm -> MRI\_CCLK -> 82 ohm -> Ground. MRI\_CCLK low level stays below 0.5 V

Place R672 130 ohm (not 82)

Place R675 82 ohm (not 130)

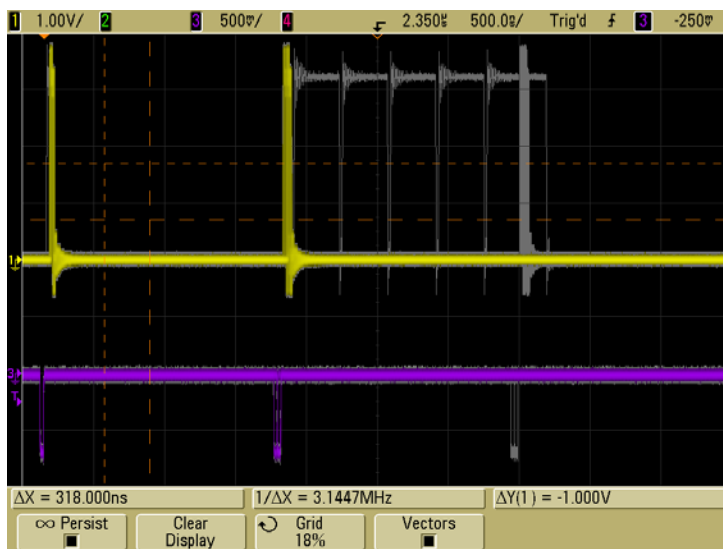
After thorough inspection the problem was reduced to the termination of the LHC\_Clk2 line. The FPGA input appears to be very sensitive in the 1.2 Volt region. On the falling edge, a hick-up can be seen (figure 22 below). This hick-up sometimes confuses the flags of the “ttc\_bus\_bit\_fifo\_1x15”. This FIFO (internal in the FPGA) is used as a bridge for the L1A signal from the LHC-Clock domain to the MROD-In system-clock domain. When the flags of this FIFO get confused then the FIFO behaves like “falling through the empty flag”, thus generating 16 spurious triggers on its output (figure 21).

Figure 21: spurious triggers on the output of the ttc\_bus\_bit\_fifo\_1x15 (internal in the FPGA)

To solve this problem, the termination of the LHC\_Clk lines was changed. The best results are obtained when a resistor is placed to ground thus the Thevenin equivalent voltage is zero in order to get the hick-up as far as possible from the 1.2 V region. Resistors of 82, 68 and 51 ohm all worked fine but 51 ohm is chosen since it is closest to the trace impedance and farthest from the 1.2 V region.

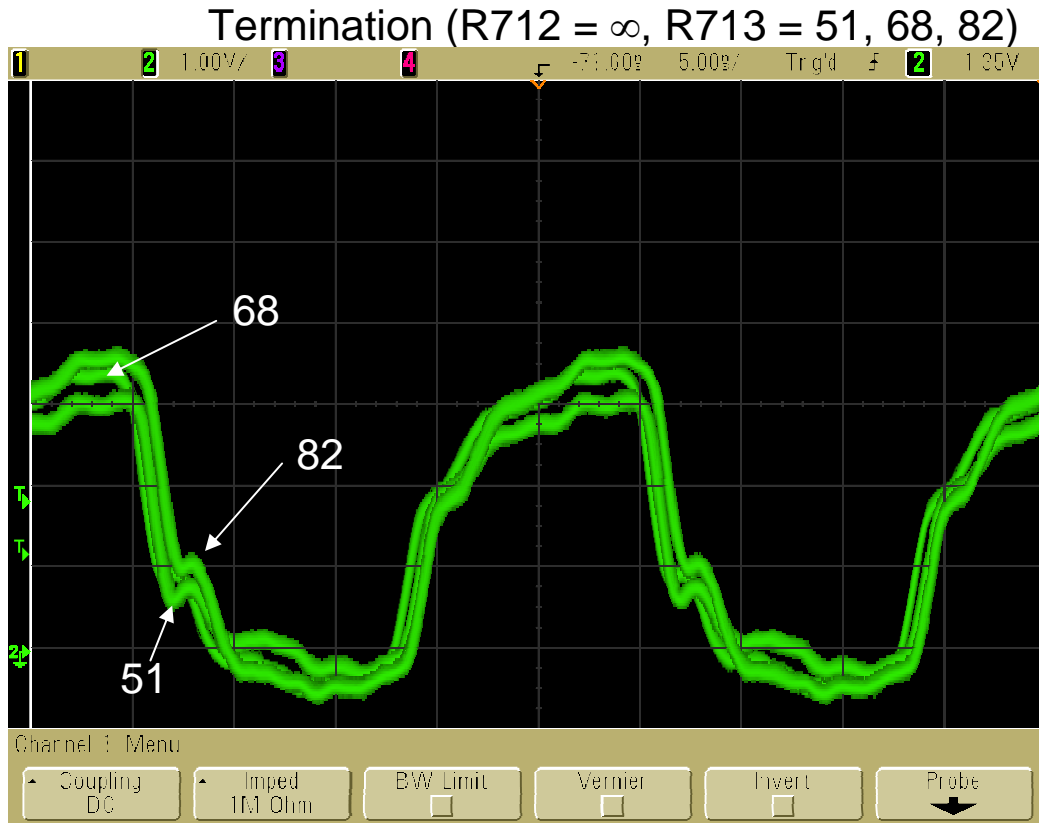
The hick-up on the LHC\_Clk2 line is not caused by a termination problem. The whole line is perfectly 50 ohms which was measured by a Time Domain Reflectometry (TDR). This shows that the Printed Circuit Board was manufactured with great care! The TDR also showed that the trace length is 4.4 ns (80 cm). The hick-up is caused by loss (in the FR4 material) of high frequency components and capacitive loading on the FPGA input pins.

Figure 22: Hick-up in the LHC\_Clk2

The LHC\_Clk2 signal was compared the other LHC\_Clk signals for the other FPGAs on the module as well as the same signal found on the prototype series (V1a). The signals found are comparable although the phenomena is only present on the pre-production series (V2), only on Channel 2B. This shows how marginally this signal is. Differences in trace routing (as compared to the other MROD input channels) or differences in Printed Circuit Board material and/or another batch of FPGAs (as compared to the proto-type series) can explain this behavior.

Don't place R710, R712, R714, R716

Place R711, R713, R715, R717 = 51 ohm (not 130)

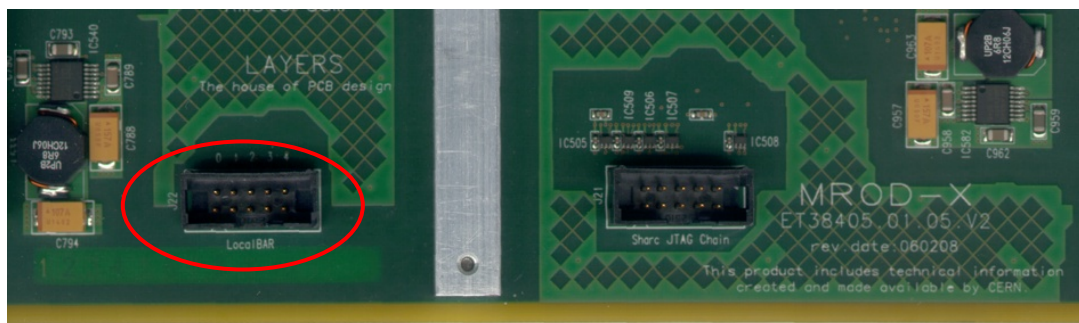
The fifteen pre-production modules all have a 2x5 pin boxed header placed for J22 (see figure 23) as was wrongly specified in the “assembly list”. For the series we kindly ask **not** to place these connectors.

Figure 23: J22 should not have been placed

Don't place J22 (Bar jumper 2x5)
