ATLAS Muon MDT

MROD-X Second Pre-Production Series Test Report

Document Version: 1
Document Issue: 1
Document ID: ATLAS-TDAQ-2007-XXX or EDMS Id XXXXXX
Document Date: 30-Mar-2007
Document Status: Final

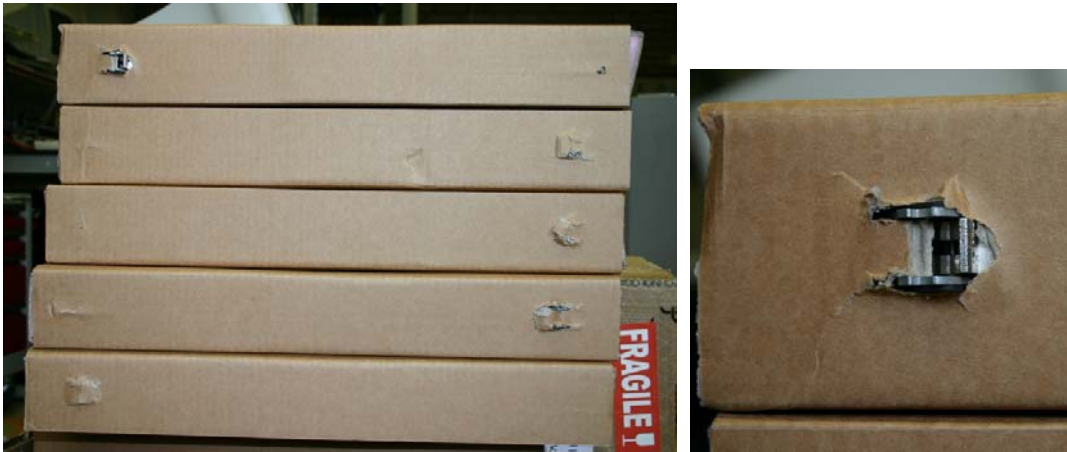
Still packaging needs improvement as can be seen in figure 3 and 4. The front panel handles bumped through the module boxes because they push directly on the bottom of the outer box without any protection. A buffer (plenty of foam, bubble-foil or chips etc.) must be placed between the bottom of the outer box and the inner boxes.

Figure 3: The front panel handles bumped through the module boxes...

Improve packaging; put **plenty of foam, bubble-foil or chips** between the bottom of the outer box and the inner boxes.

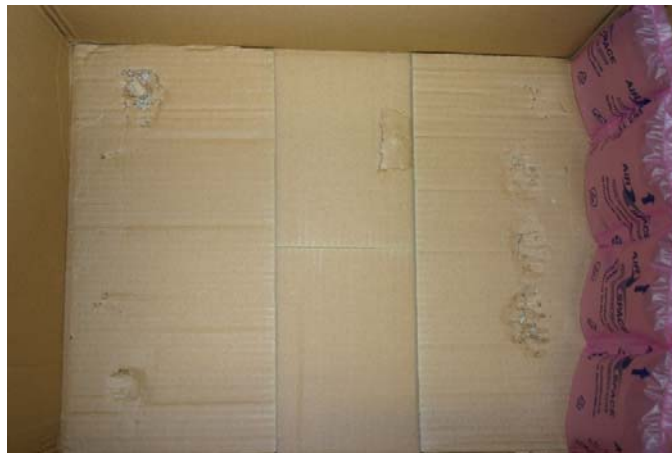
Figure 4: ... into the bottom of the outer box

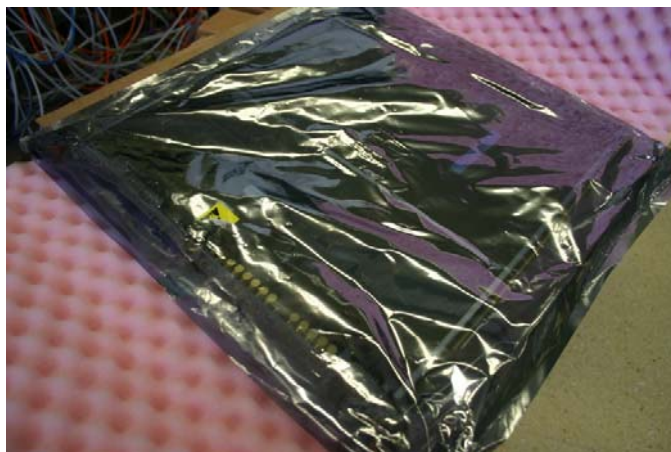
The boards were not packaged in anti-static bags. This needs to be done for the series. Without such a bag the components mounted on the board scrape parts of the foam, which get all over the module. Figure 6 shows how it was expected that the modules would arrive.

Figure 6: Use an anti-static bag to package the modules into the special boxes.

Anti-static bags will be sent from Amsterdam to PCB Technologies so the production series can be properly packaged.

Use an **anti-static bag** before the module is packed into the special module box.

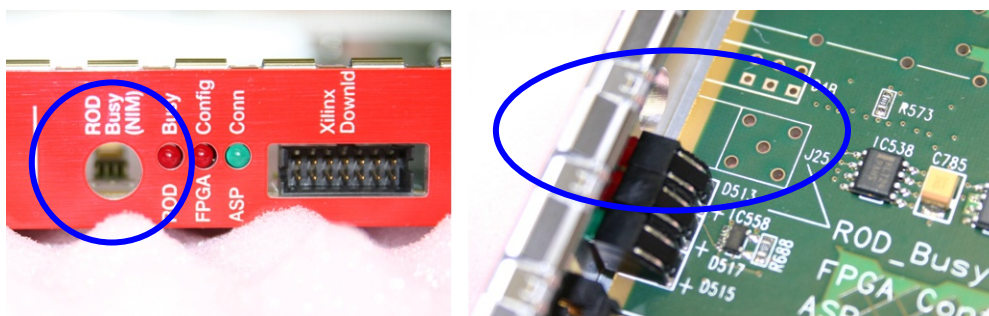
The front panel “ROD Busy” LEMO connector (J25) is one of the items that were properly assembled on the first pre-production series but were not placed on the second pre-production series (see figure 7).

Figure 7: ROD Busy LEMO connector (J25) was not assembled

Assemble J25 (ROD Busy LEMO)

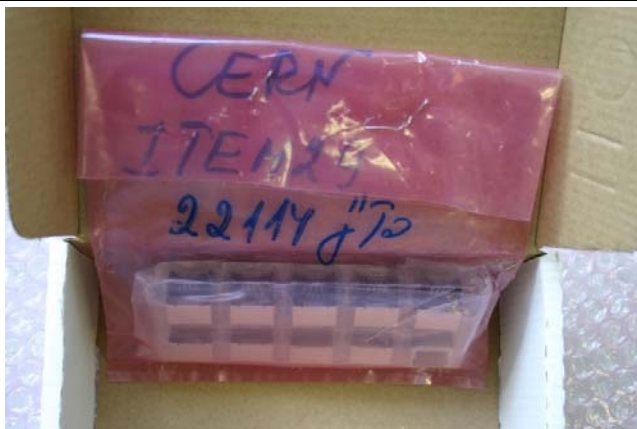
Apparently components had been swapped with other CERN projects since there were ten “RJ45” connectors (figure 8) separately packed. According to PCB-Technologies “these connectors didn’t fit the LEMO connector on the MROD module”. The text on the bag in figure 8 shows “item-29”. By mistake this item was swapped for the MROD project item-29 which is the ROD Busy LEMO connector.

Figure 8: Item-29 of another CERN project

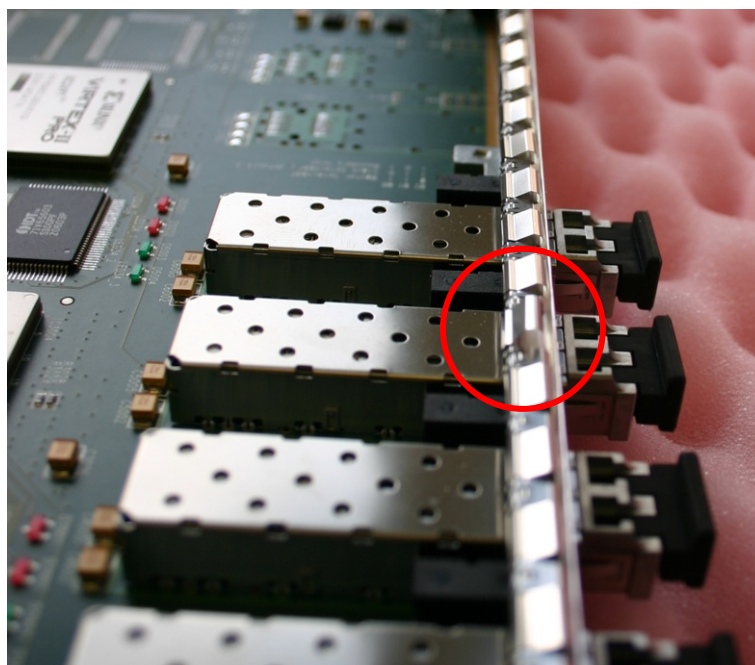
For the second pre-production series it was asked **not** to place the EMC Gaskets (RITTAL number 3686979) since they were found to be of inferior quality on the first pre-production series. However, all second pre-production modules had the EMC Gasket assembled (see figure 9). This figure also shows why the gaskets are of inferior quality; the springs sometimes get deformed which can cause damage on the components that are mounted on neighbouring modules when boards are put into or taken out of a VME Crate.

Figure 9: Inferior EMC Gasket was assembled. Encircled is a deformed spring.

Do not place the EMC-Gasket. We now have better ones that we will mount in Amsterdam.

Do **not** assemble the EMC Gaskets (RITTAL Number 3686979)

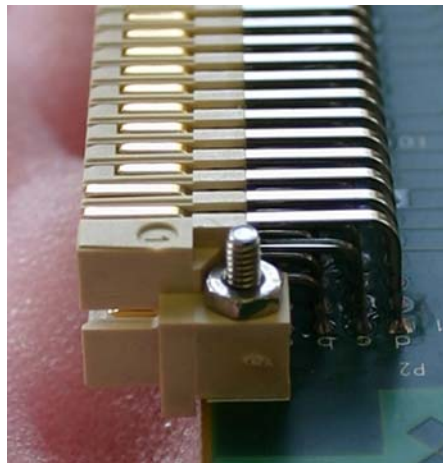
Connectors P1, P2 and P3 were mechanically fixed with M2x12 bolts (figure 10). For the series M2.5x10 should be used. There are two reasons to change to M2.5x10.

First, the holes in the connector and on the PCB are made for M2.5 bolt and thus a M2 bolt has clearance which can lead to a misalignment during the soldering of the connector.

Second, the M2x12 is unnecessary long. To keep maximum clearance to the neighbouring boards M2.5x10 is sufficient.

Figure 10: M2x12 was used to mechanically fix P1, P2 and P3. Use M2.5x10 instead.

A sufficient number of M2.5x10 bolts and nuts will be sent from Amsterdam to PCB Technologies so the connectors on the production series can be properly fixed.

Mechanically fix P1, P2 and P3 before soldering with **M2.5x10**

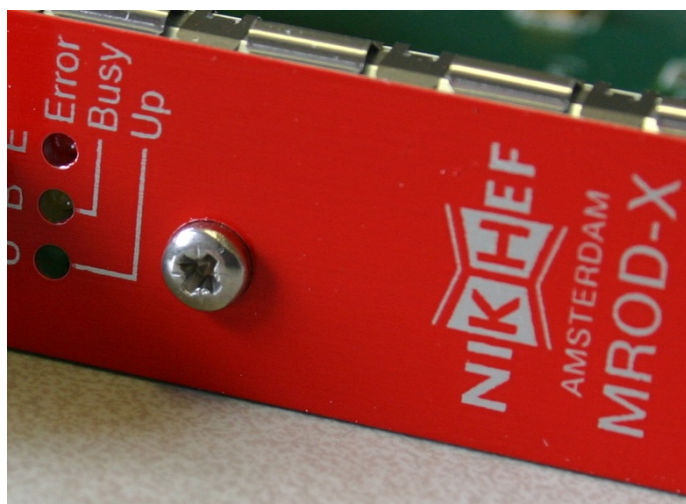
The front panel was properly assembled on the first pre-production series but wrong bolts were used for the second pre-production series (figure 11). The assembly list states on page 19, to use a “countersunk head M2.5x6 for mounting the front panel to the PCB holder”.

Figure 11: a countersunk head M2.5x6 must be used instead of a cheese head

A sufficient number of M2.5x6 countersunk head bolts will be sent from Amsterdam to PCB Technologies so the front panel on the production series can be properly fixed.

Use a **countersunk head M2.5x6** for mounting the front panel to the PCB holder

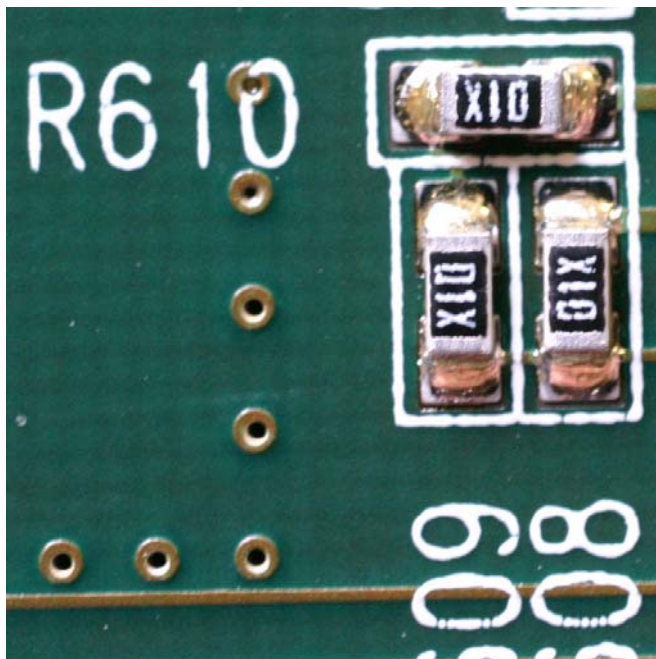
There are many (switched mode) power supplies on the board. The feedback resistors need to have the proper values to avoid over-voltage on the FPGAs or SHARC processors. Not all resistors had the proper value. It seems that there was a wrong tape placed on the machine since for all 100 ohm resistors, 10 ohm resistors were placed instead. This involves 15 resistors per module (R605, R608, R609, R610, R719, R720, R721, R1006, R2006, R3006, R4006, R5006, R6006, R7006, R8006)

The proper EIA-96 marking for a 100 ohm SMD resistor should read “01A”. However 10 ohm resistors with marking “01X” were placed.

It should be noted that the same error was made in the first pre-production series!

Figure 12: example of resistors with wrong values

R605, R608, R609, R610, R719, R720, R721, R1006, R2006, R3006, R4006, R5006, R6006, R7006, R8006 **must be 100 Ω** (not 10 Ω)

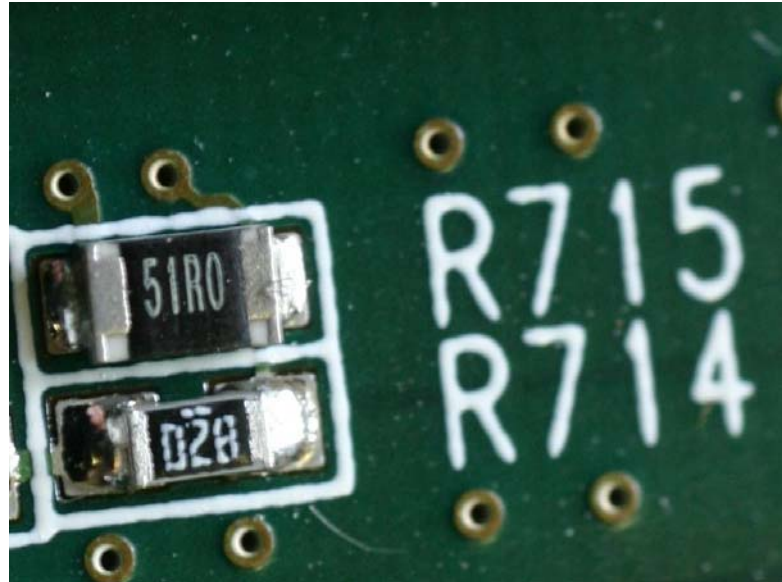
New insights from the first pre-production series led to the instruction **not** to place R710, R712, R714, R716. This instruction was not followed as can be seen in figure 13.

New insights from the first pre-production series led to the instruction to replace R711, R713, R715, R717 by a 51 ohm resistor. This instruction was indeed followed, however a **0603 SMD size must be used**, not a 0805 (see figure 13).

Figure 13: Example; R714 must **not** be placed, R715 must be a **0603** package, not a 0805 package

Don't place R710, R712, R714, R716

Place R711, R713, R715, R717 = **51 Ω** (not 130 Ω) **in 0603 package**

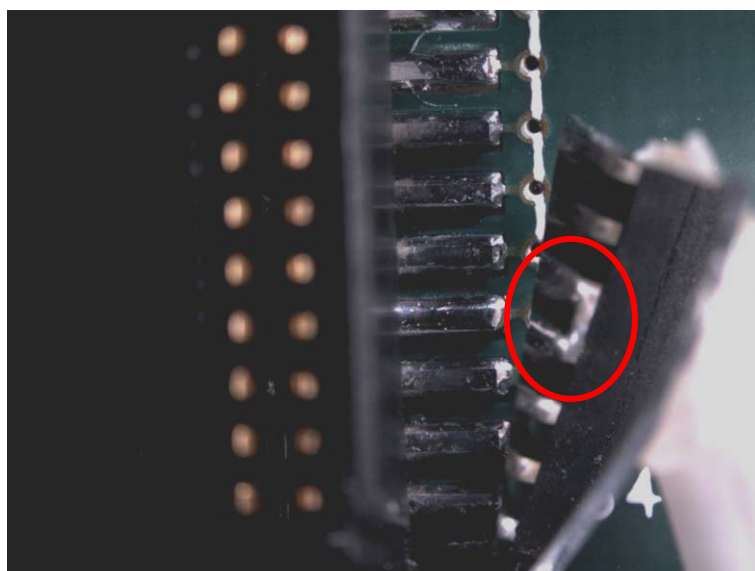
4.2 Module 30, J24 short between pins 56 and 58

This module did not pass the test and software soon pointed to connector J24 pins 56 and 58. It appeared that PCB technologies had done some rework on pins 52 to 64. After closer inspection with a tiny mirror, one can see that there is a short between pins 56 and 58 (see figure 14).

Figure 14: J24 pins 56 and 58 are shorted

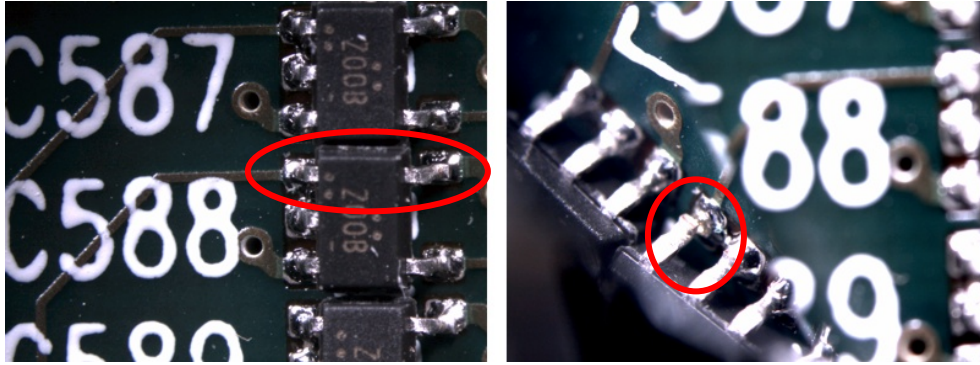
4.3 Module 31, IC588 pin 1 and 5 not soldered properly

This fault is caused by the package of the NC7SZ00P5X which is not really flat on the PCB thus causing the pins to stand off from the PCB surface (see figure 15).

This problem area was already noticed while testing the first pre-production series and it was recommended to pay extra attention to IC588. This fault proves that extra attention for IC588 is indeed necessary!

Figure 15: IC588 pin 1 and 5 above the PCB and not soldered

Keep paying special attention to IC588 area
