Final operations to be performed in the production sites prior to shipment of modules

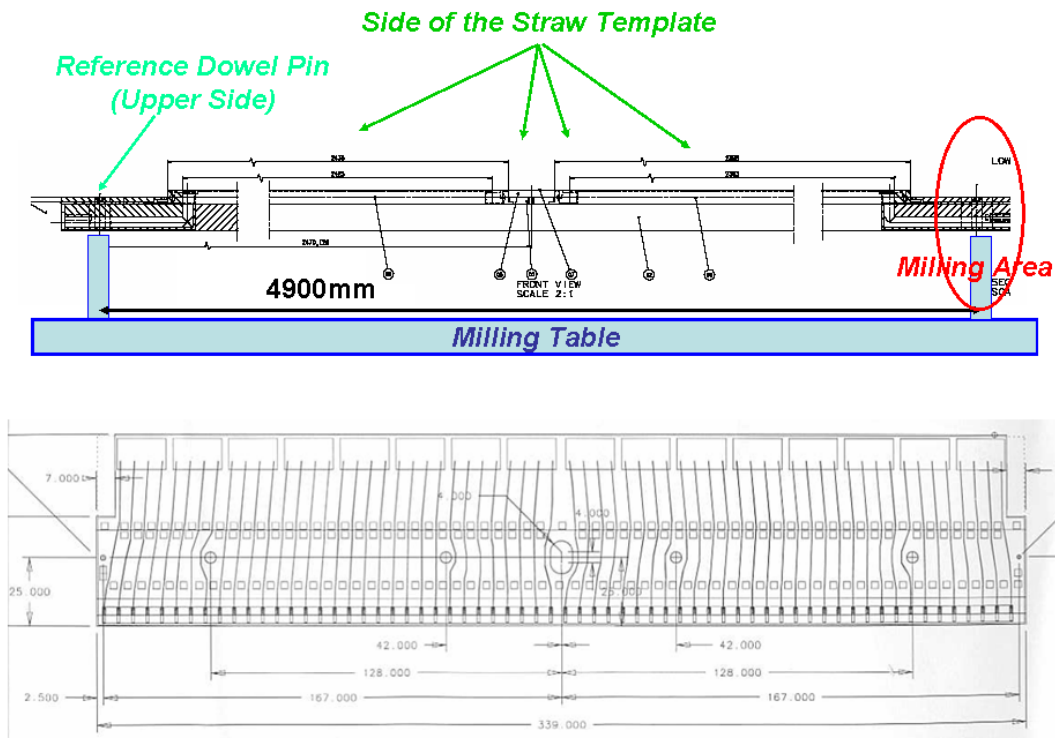
- 4) Adjust slotted hole
 - a. **Description:** various effects spoil the accuracy of the slotted holes in the Aluminum (8mm) or plastic (4mm) inserts:
 - i. Wrong machining and excess glue and poor cleaning/filing during panel lamination at Cracow
 - ii. Wrong superposition of panel and FT boards slotted hole, due to panel expansions with respect to nominal (straw template) length
 - iii. Excess glue in the panel assembly procedure (from the spacer)
 - b. **Solution:** remachining of the slotted hole, as shown in Fig.1
 - c. **Test:**
 - i. check hole dimension with go/no-go calibers
 - ii. check panel length (pin-2-pin) and write it down

Figure 1 Side view of the Milling Setup (top) and Lower Feed-Through Board Layout (bottom).

- 1) one assumes that the module fits in the milling template
- 2) one expects the Lower FT to be in the nominal position, since it has been carefully adjusted in the Straw Template, and thus **no damage to the vias in the PCB to result**. In case of doubt, the figure above shows where vias are in the PCB layers
- 3) one expects that achieving the nominal distance between the dowel-pin hole centres means **milling into the Aluminum inserts** in case in which panels are shorter/longer (usually shorter 1-2mm) than the nominal.
