Final operations to be performed in the production sites prior to shipment of modules

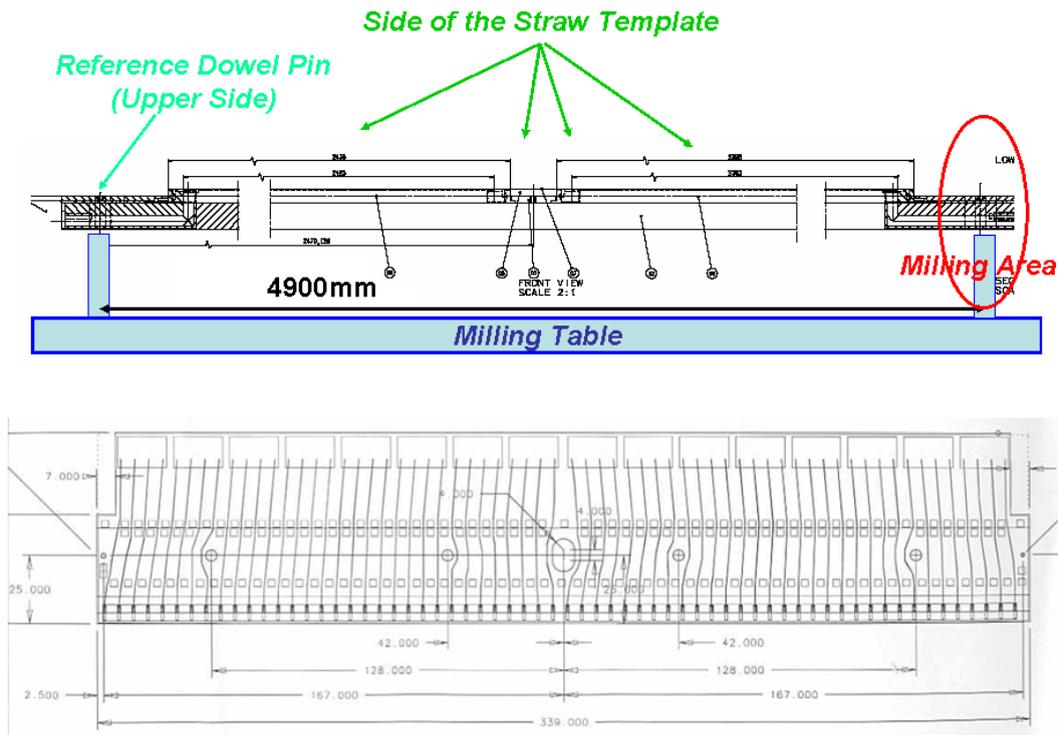
Figure 1 Side view of the Milling Setup (top) and Lower Feed-Through Board Layout (bottom).

- 1) one assumes that the module fits in the milling template
- 2) one expects the Lower FT to be in the nominal position, since it has been carefully adjusted in the Straw Template, and thus **no damage to the vias in the PCB to result**. In case of doubt, the figure above shows where vias are in the PCB layers
- 3) one expects that achieving the nominal distance between the dowel-pin hole centres means **milling into the Aluminum inserts** in case in which panels are shorter/longer (usually shorter 1-2mm) than the nominal.

- 4) Adjust slotted hole
 - a. **Description:** various effects spoil the accuracy of the slotted holes in the Aluminum (8mm) or plastic (4mm) inserts:
 - i. Wrong machining and excess glue and poor cleaning/filing during panel lamination at Cracow
 - ii. Wrong superposition of panel and FT boards slotted hole, due to panel expansions with respect to nominal (straw template) length
 - iii. Excess glue in the panel assembly procedure (from the spacer)
 - b. **Solution:** remachining of the slotted hole, as shown in Fig.1
 - c. **Test:**
 - i. check hole dimension with go/no-go calibers
 - ii. check panel length (pin-2-pin) and write it down
