Corrosion and pressure action of the deep-sea on the NESTOR floor-detector

We started collecting data about influence of pressure and corrosion from first tests of elements of deep-water neutrino telescope NESTOR. In the given paper the results of the analysis of conditions of elements from the NESTOR test-detector which was exposed long time at the depth of 4000 m in the Mediterranean Sea are presented. This experience should be taken into account upon creation deep under water neutrino telescope.

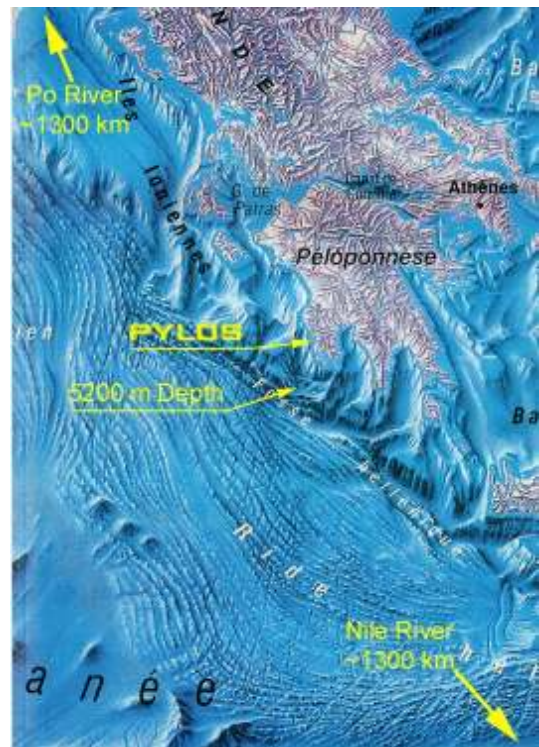
First long-term tests were started when in 2000. A 30 km-long deep sea cable with 18 mono mode optical fibers is laid from the shore to the deep-sea site (Fig.1). One copper conductor can deliver up D.C. power. The scientific payloads are attached at the end of cable. The sea end of cable is hoistable in order to change the deepwater equipment. The cable landing is terminated in the Terminal cable station in the village of Methoni (11 km from Pylos).

Fig.1. The NESTOR site.

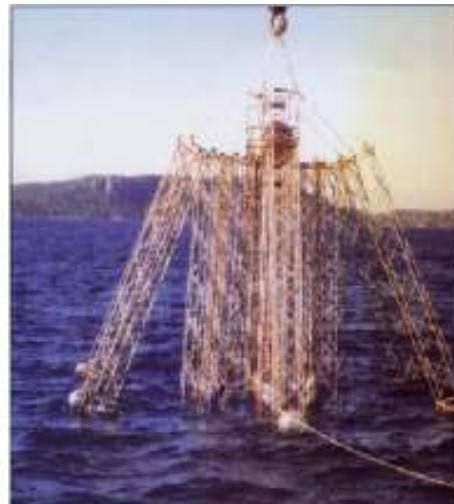
In March of 2003 the pyramid was brought back to the surface. The floor of the NESTOR test-detector, made out with Ti, was connected and deployed. The present detector floor structure measures only 12 m in diameter but consists of the usual 6 arms and is equipped with 12 OMs. The detector floor was mounted some 150 m above the anchor. There are LED calibration pulse modules installed 20 m above and 20 m below the center of the floor plane.

Fig.2. The NESTOR Ti-floor

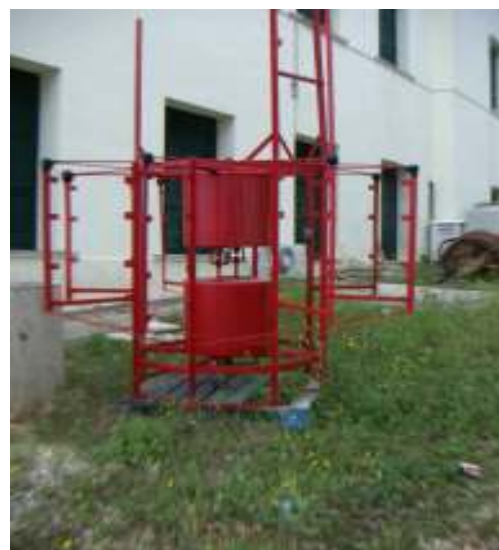
We were surprised a little when found so slight corrosion on the parts which were taken out from the depth. Even made from mild steel the buoy's frame was slightly covered by spots of pitting corrosion. Of cause it was protected with Zn-anodes and painted by special protective vanish. In any

Fig.5. The buoy's frame from NESTOR test-detector is ready for new deployment

case the frame has returned from the depth in a very good condition and will be used again (see Fig.5). It should be mentioned also that after a long time of installation on the sear floor in 4000 m of water, there has been no visible indication of corrosion on the aluminum pyramid.

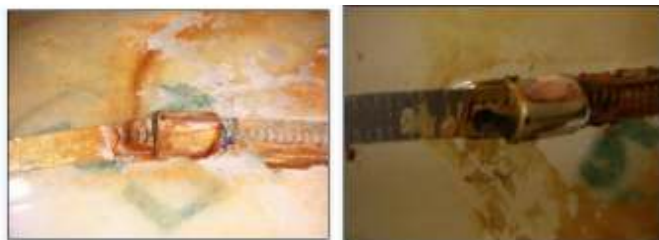
One more corrosion attack took place on the stainless steel straps girdled BENTHOS spheres. Bolts on the buckles were completely destroyed by crevice corrosion (Fig.8). The weakening of the straps is not dangerous for BENTHOS spheres. However a settling of the rust on the BENTHOS's surface at the side of photo cathode can spoil sensitivity of the OM.

Fig.8 Result of corrosion attack to the buckle on stainless steel straps girdled around BENTHOS sphere.
