Nikhef VELO module measurement results

Test setup

- 6 LVDT sensors
- 16 temperature sensors PT100
- Temperature control for frame
- Vacuum pressure better than 10^{-4} mbar

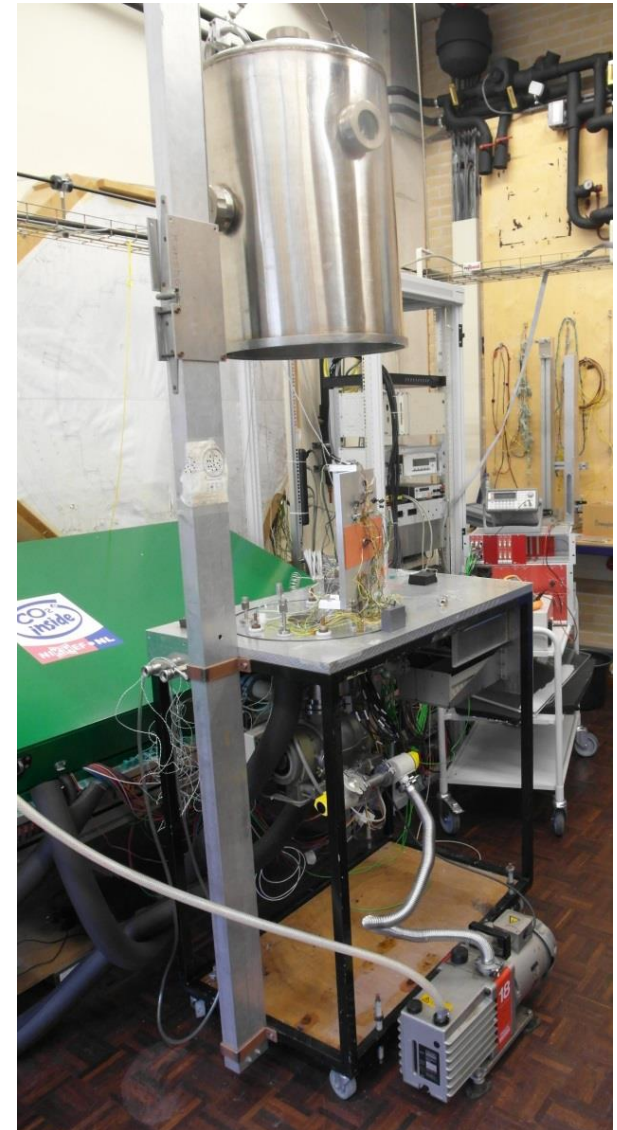
Location sensors

Temperature sensors

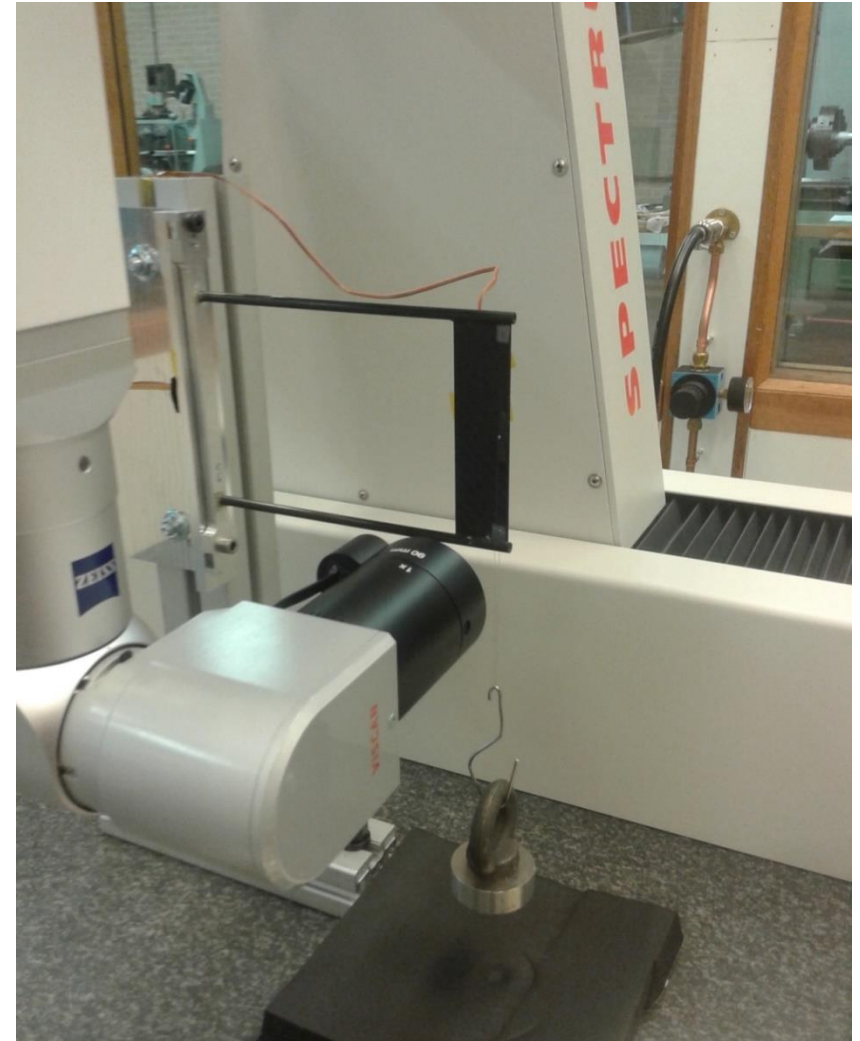
Creep test VELO hurdle

- 3 weeks with a constant load of 420 grams
- Accuracy $\pm 4 \mu\text{m}$

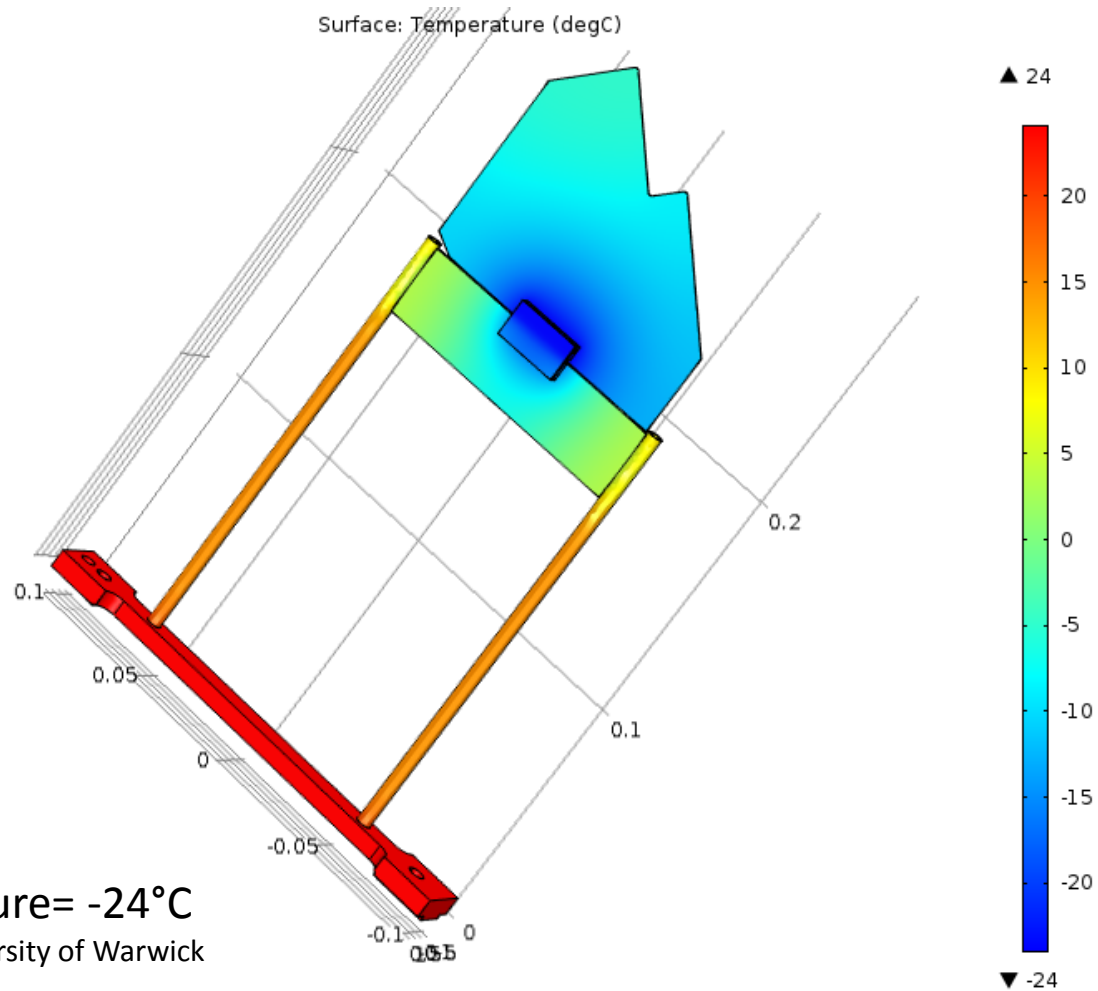
Thermal model with convection

Cooling block temperature = -24°C

Thermal model by John Back, University of Warwick
