ATLAS Muon MDT

MROD-X Second Pre-Production Series Test Report

Document Version: 1
Document Issue: 1
Document ID: ATLAS-TDAQ-2007-XXX or EDMS Id XXXXXX
Document Date: 30-Mar-2007
Document Status: Final

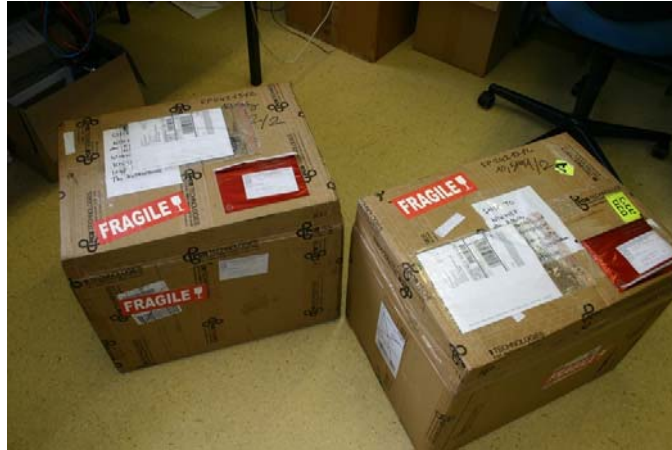
Figure 1: Arrival of the boxes in Amsterdam

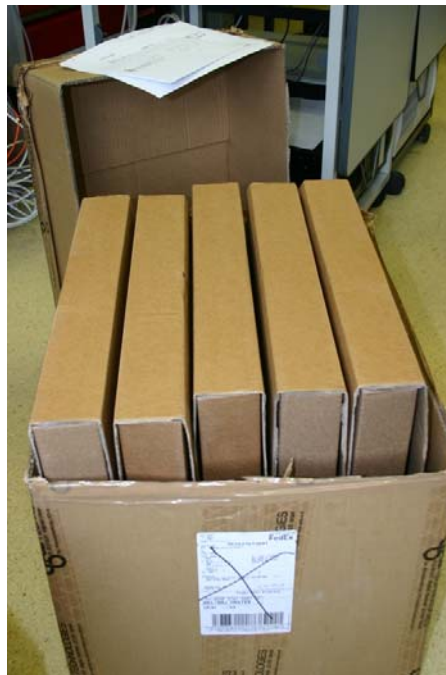
Figure 2: One of the boxes was just opened

Still packaging needs improvement as can be seen in figure 3 and 4. The front panel handles bumped through the module boxes because they push directly on the bottom of the outer box without any protection. A buffer (plenty of foam, bubble-foil or chips etc.) must be placed between the bottom of the outer box and the inner boxes.

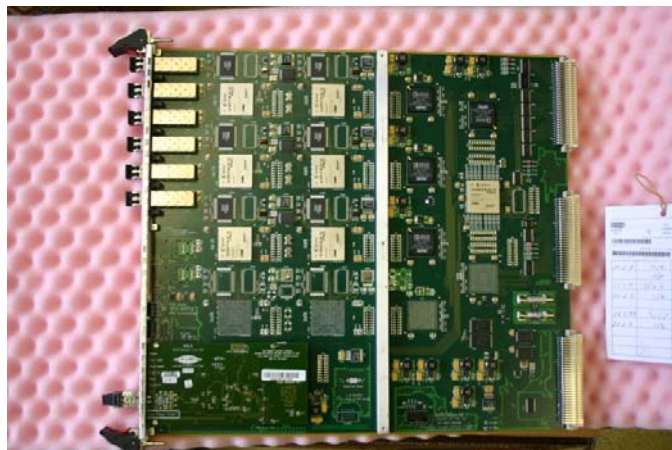
Figure 5: One of the modules just being unpacked after arrival

The boards were not packaged in anti-static bags. This needs to be done for the series. Without such a bag the components mounted on the board scrape parts of the foam, which get all over the module. Figure 6 shows how it was expected that the modules would arrive.
