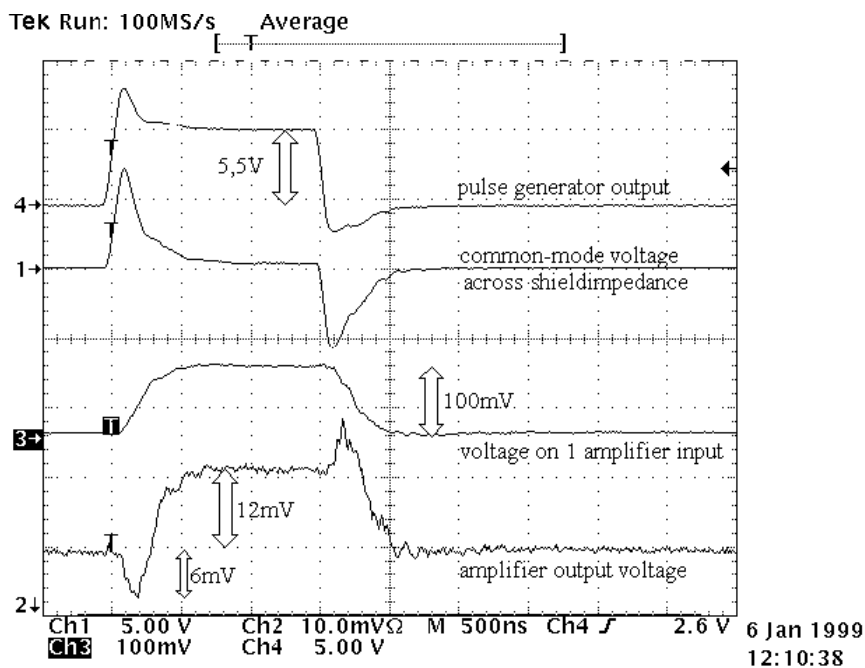
Fig. 2

Fig.2 shows the pulse generator output, the common-mode voltage across the shield, the voltage on one of the signal wires, and the amplifier output voltage. On both edges of the channel 1 signal we see an overshoot, caused by the inductance of the cable. This transient couples capacitively into the two wires of the twisted pair. Due to the asymmetry of the cables, the effect on the output voltage happens to come out inverted.

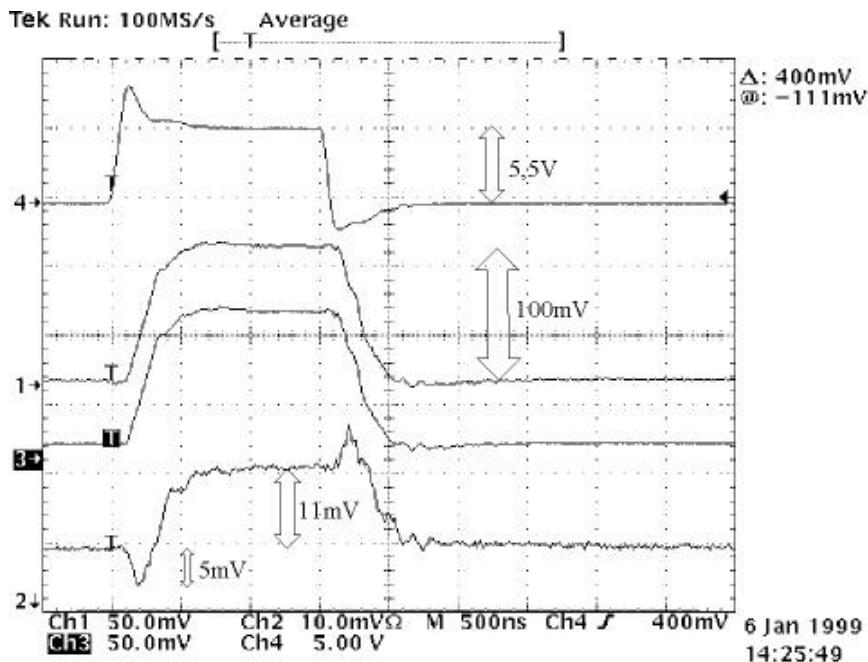
Channel 1 and channel 3 in Fig.3 display the signals on the two inputs of the amplifier.

With the scope's resolution, the asymmetry between the two signals causing the transients is not detectable: after all with an amplifier gain of 36, and an overshoot value of 5 mV on the output, we are looking for an input signal of 138 microvolts. Note that the Ch.3 sensitivity has changed to 50mV/div.

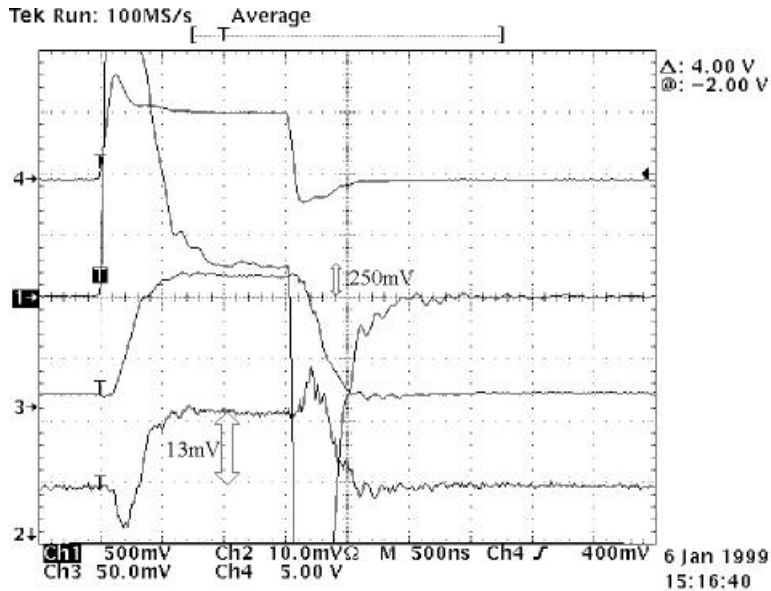
Fig. 4

After the transient has died out, the flat part of the common mode voltage remains. In fig. this is shown on channel 1. The current flowing through the shield can be calculated: $250\text{mV}/2,425\text{ohm} = 103\text{mA}$. The common mode rejection ratio can now be expressed in two ways: 1) outputvoltage/gain divided on the inputvoltage, or: 2) outputvoltage/gain divided by shieldcurrent.

1) CMRR: $250 \times 36 / 13 = 692,3$ which equals 57dB.

2) CMRR: $13 / 36 \times 103 = 3,5\text{uV/mA}$

The outputvoltage has been calculated back to the input.

The transient across the shield (fig. channel1) is caused by the selfinductance of the cables shield: the time is determined by the selfinductance and the total resistance in the circuit: 52,45 ohms.

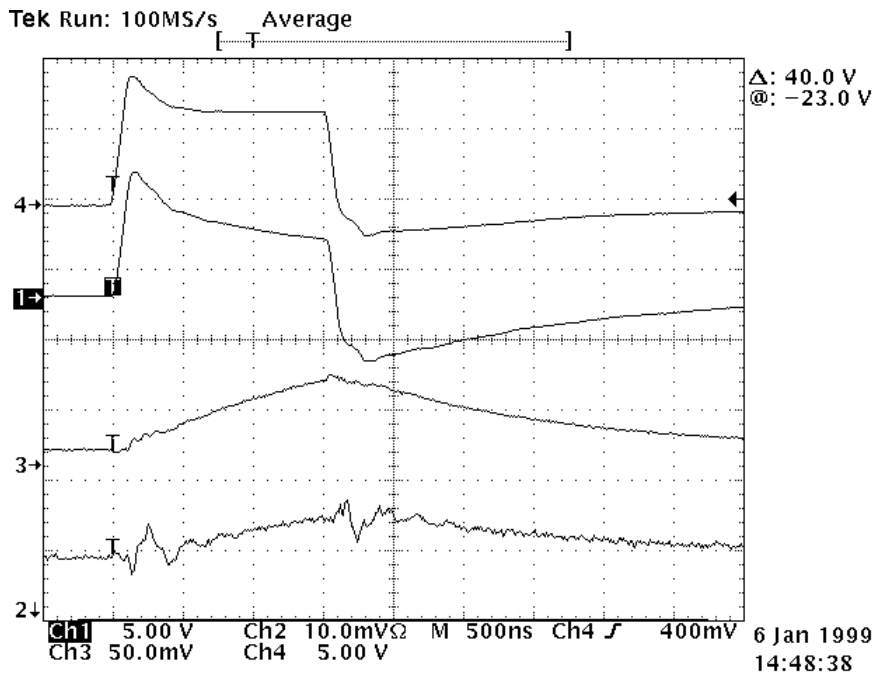
Fig.5

The next picture, fig.5 shows the effect on the CMM behaviour when 5 turns of the cable are fed through an E42-3C8 core. The impedance in the path increases, resulting in a higher voltage on the inputside of the shield for the timeslot being observed. As a result the signal on the input of the amplifier (Ch.3) gets slower, losing high frequency components. Yet, the transients on the output of the amplifier (Ch.2), although smaller, remain! This supports the earlier idea that these transients are being caused by the asymmetry of the cable: in this case the capacitive asymmetry, because increasing the inductance by adding some ferrite doesn't help.

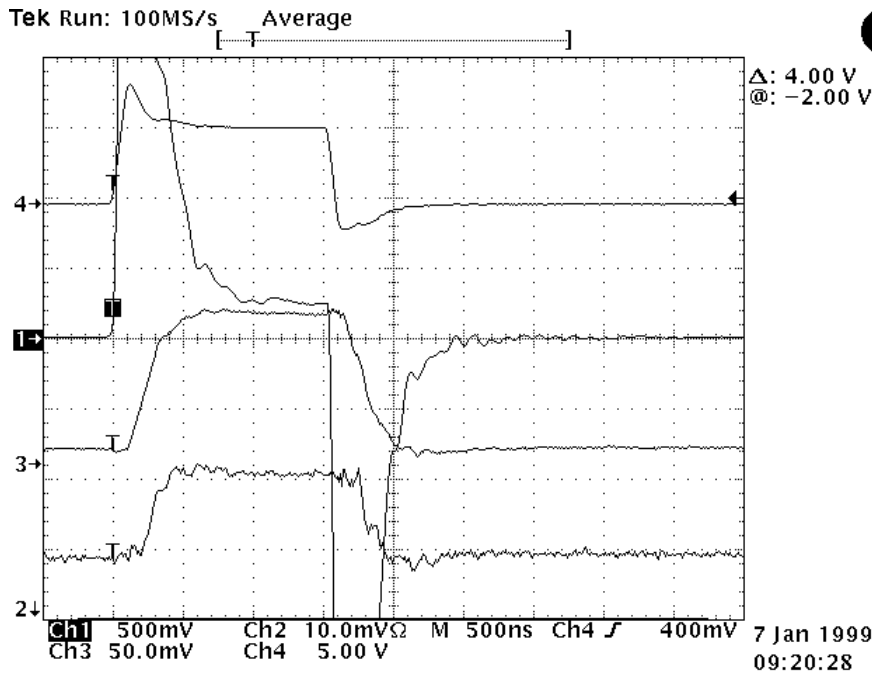
Fig.6

In fig.6 we can see the effect of a compensation capacitance of 15pF connected from one of the inputs to ground. No ferrite was used here. The transients on the output (Ch.2) have practically gone.

This compensation should work for common-mode noise on both signal-wires as well.
