TS / MME – CCS
Chemistry Laboratory

Analytical Chemistry		<i>N° EDMS</i>																										
		<i>N° MME-CCS : X-36/07.07</i>																										
Applicant :		Reception date: 26.07.2007																										
Antonio Pellegrino PH/ULB - 162572	Sébastien Bachmann PH/ULB - 162038																											
Object of request : <i>Cleanliness state control of stainless steel tubes for LHCb Outer Tracker gas systems in point 8 (LHC).</i>																												
Samples : <ul style="list-style-type: none"> [1]: RackROA13 side A Output 204(35)-OT [2]: Rack ROA13 side A Input 202(28)-OT [3]: Rack ROA13 side C Input 201-OT [4]: Rack A3BO4 side A Output 204-OT [5]: Rack A3BO4 side C Output 203-OT-CRLP P250 [6]: Rack A3BO5 side C Input 201-OT-CRLP249 																												
Sampling : The sampling extractions were realized in the LHCb cavern, using PTFE filters and n-hexane. Two filters were used by pipe.																												
Method, instrument, norms : <ul style="list-style-type: none"> – FT-IR Spectrometry; Instrument : Bruker Vertex 70. – Procedure: SM-CP: EDMS Nr. 410981 – “Identification de produits siliconés présents comme contaminants sur différents supp

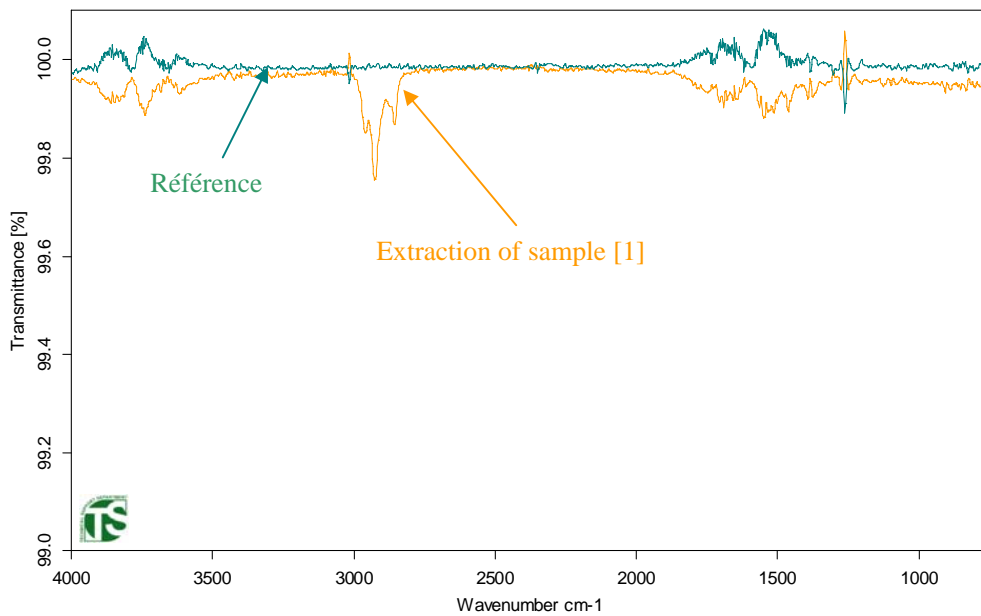
Spectrum MME-CCS X-38/08.07 Fig. 1

<table><tr> <th>Sample number</th> <th>Results/comments</th> </tr><tr> <td>[1]</td> <td>Traces of Hydrocarbons products</td> </tr></table>

FT-IR Spectrum to the extraction of sample [1] - reference (IRTRAN 2 window)

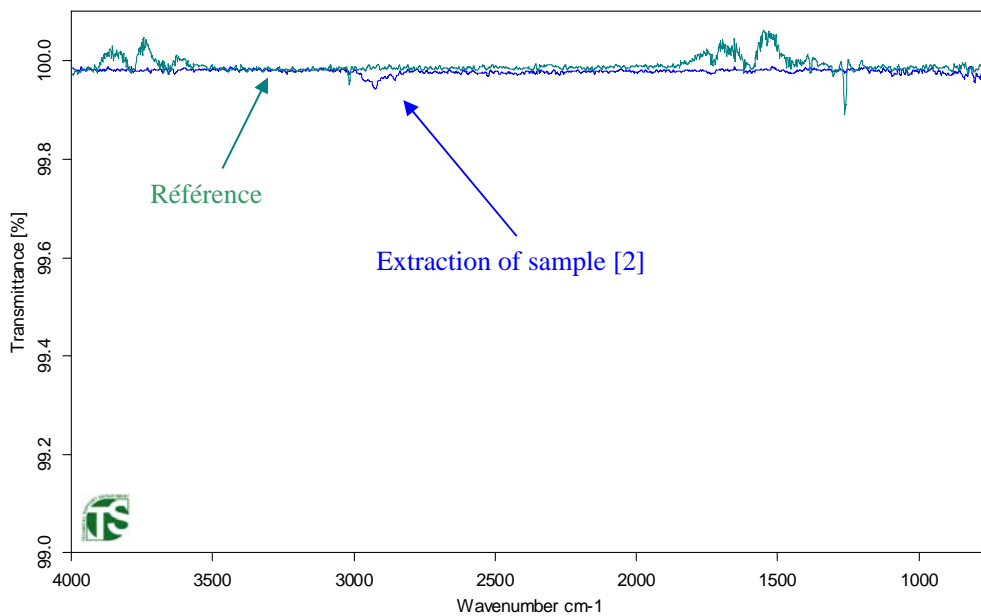
Spectrum MME-CCS X-38/08.07 Fig. 2

<table><tr> <th>Sample number</th> <th>Results/comments</th> </tr><tr> <td>[2]</td> <td>Negligible Traces of Hydrocarbons products</td> </tr></table>

FT-IR Spectrum to the extraction of sample [2] - reference (IRTRAN 2 window)

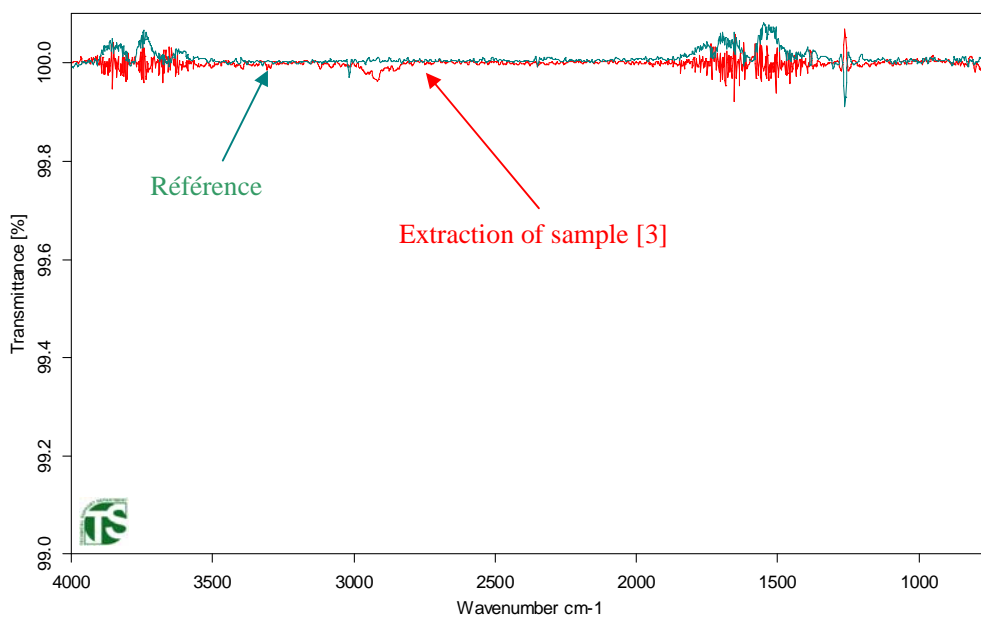
Spectrum MME-CCS X-38/08.07 Fig. 3

<table><tr> <th>Sample number</th> <th>Results/comments</th> </tr><tr> <td>[3]</td> <td>Negligible Traces of Hydrocarbons products</td> </tr></table>

FT-IR Spectrum to the extraction of sample [3] - reference (IRTRAN 2 window)

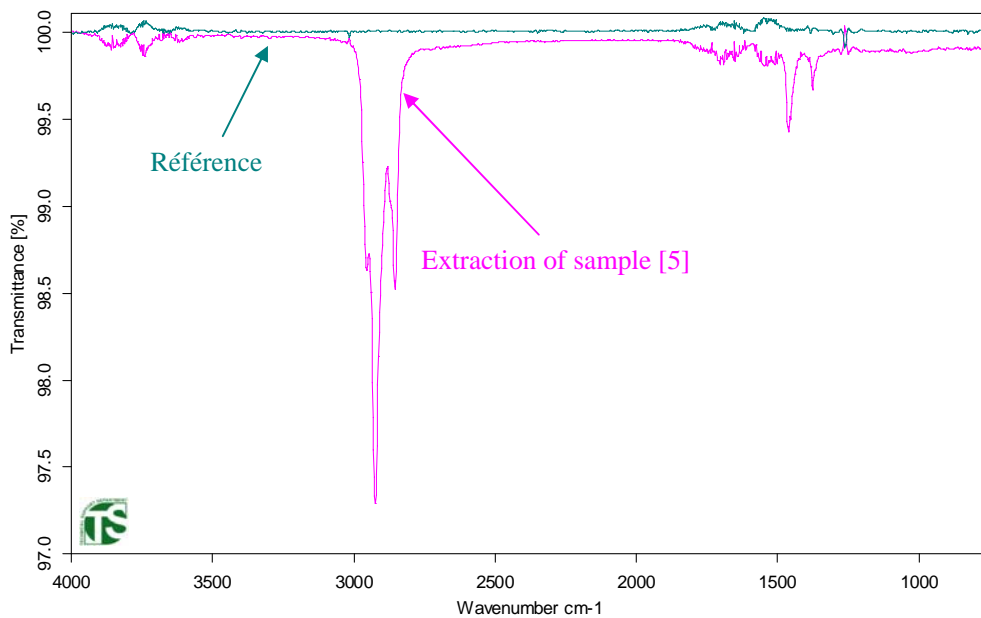
Spectrum MME-CCS X-38/08.07 Fig. 5

<table><tr> <th>Sample number</th> <th>Results/comments</th> </tr><tr> <td>[5]</td> <td>Pollution by Hydrocarbons products</td> </tr></table>

FT-IR Spectrum to the extraction of sample [5] - reference (IRTRAN 2 window)

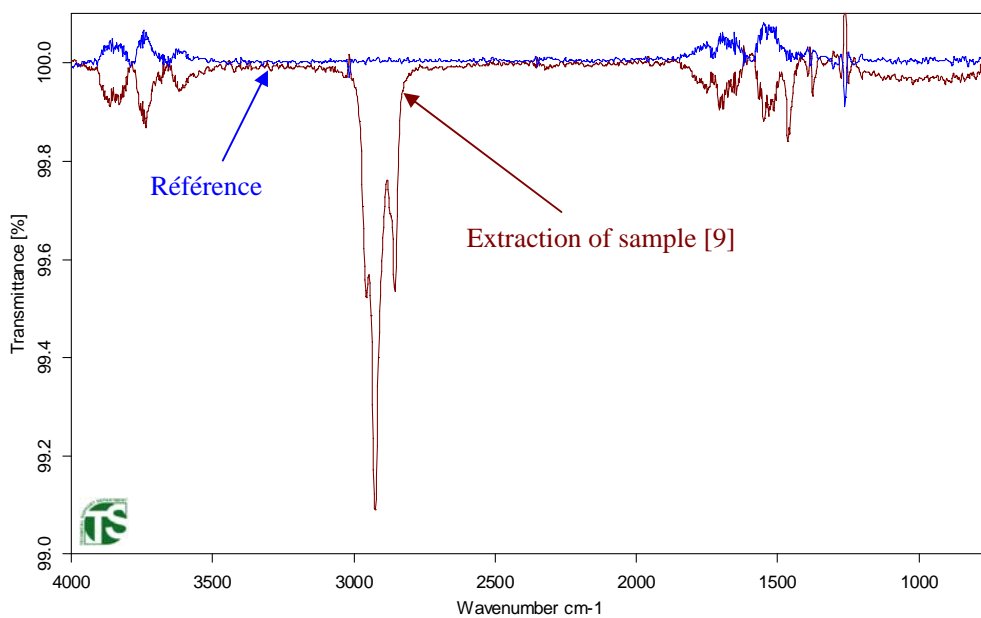
Spectrum MME-CCS X-38/08.07 Fig. 9

<table><tr> <th>Sample number</th> <th>Results/comments</th> </tr><tr> <td>[9]</td> <td>Non negligible traces of Hydrocarbons products</td> </tr></table>

FT-IR Spectrum to the extraction of sample [9] - reference (IRTRAN 2 window)

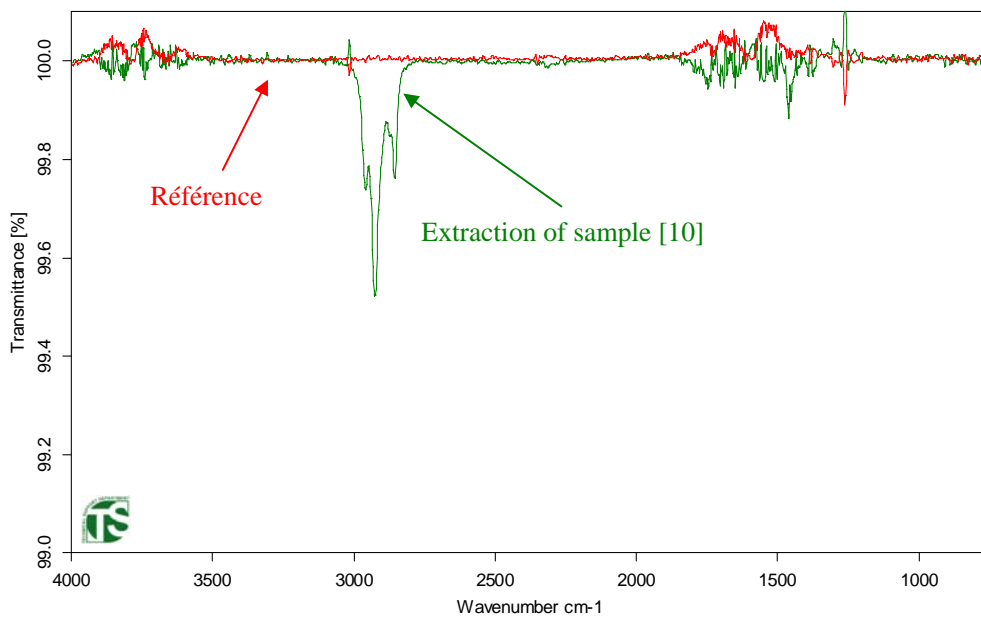
Spectrum MME-CCS X-38/08.07 Fig. 10

<table><tr> <th>Sample number</th> <th>Results/comments</th> </tr><tr> <td>[10]</td> <td>Non negligible traces of Hydrocarbons products</td> </tr></table>

FT-IR Spectrum to the extraction of sample [10] - reference (IRTRAN 2 window)

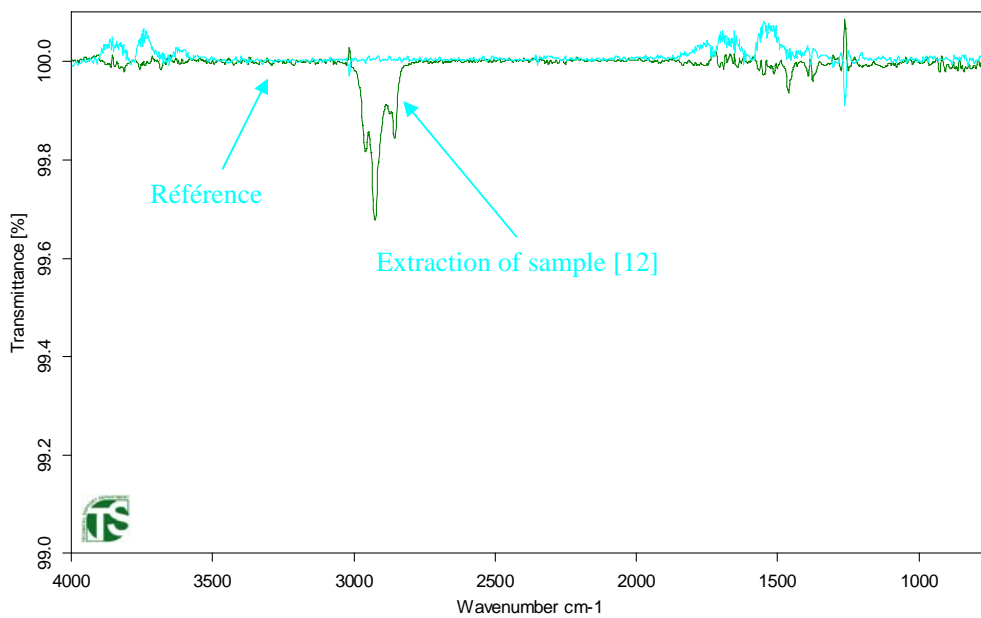
Spectrum MME-CCS X-38/08.07 Fig. 12

<table><tr> <th>Sample number</th> <th>Results/comments</th> </tr><tr> <td>[12]</td> <td>Traces of Hydrocarbons products</td> </tr></table>

FT-IR Spectrum to the extraction of sample [12] - reference (IRTRAN 2 window)
